Access Compliance Report

Public Rights-of-Way

(Curb Ramps)

Intersection ID: 17594	Main Street: MALLEN_DR	Cross Street: WINCHELSEA_DR	Location: SW
ADA ID: DFB04C44D01B	Ramp Type: PerpDiag	Initial Pass/Fail: Fail	Overall Compliance: No
			Severity Score: 13.75

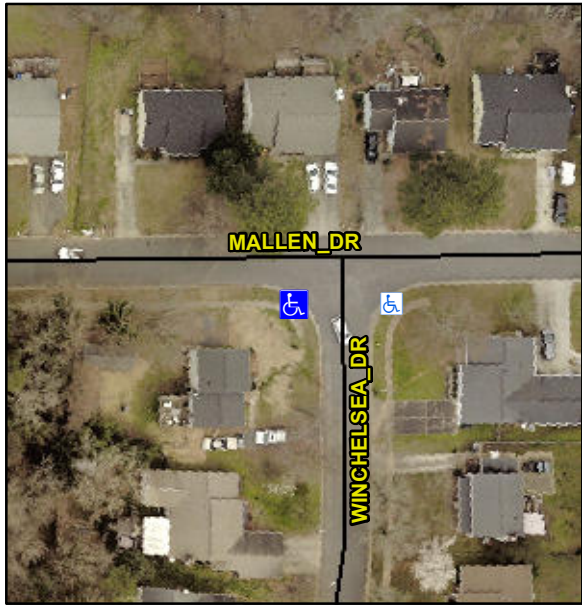
Possible Solutions:		Compliance	Description	Data	Compliance	Description	Data
	Remove & Replace Curb Ramp With Two New Directional Ramps or Equivalent.		N/A	Ramp Length (in)	80.0	No	Ramp Slope (%)	8.8
			Yes	Ramp Width (in)	48.0	No	Ramp XSlope (%)	2.1
			N/A	Flare Type LT	N/A	N/A	Flare Type RT	N/A
			N/A	Flare Slope LT (%)	N/A	N/A	Flare Slope RT (%)	N/A
			N/A	Flare Traversable LT?	N/A	N/A	Flare Traversable RT?	N/A
			N/A	Landing Length (in)	N/A	N/A	DWS Provided?	N/A
			N/A	Landing Width (in)	N/A	N/A	DWS Contrast?	N/A
			N/A	Landing Slope (%)	N/A	N/A	DWS Length (in)	N/A
			N/A	Landing X Slope (%)	N/A	N/A	DWS Full Width?	N/A
Street 1 Name	Surveyor Notes:		N/A	Landing Curb? (Y/N)	N/A	N/A	DWS Offset (in)	N/A
	N/A		N/A	Shared Landing?	N/A			
	PROW/ADA:		N/A	Gutter Ponding?	N/A	N/A	Gutter Slope (%)	N/A
	Not Found, R304.2.2, R304.5.3		N/A	Gutter Lip Ht (in)	N/A	N/A	Gutter X Slope (%)	N/A

N/A	Painted X Walk1?	No	N/A	Painted X Walk2?	No
				X Walk 1 Direction	To E		X Walk 2 Direction	To N
			N/A	X Walk 1 Width (in)	N/A	N/A	X Walk 2 Width (in)	N/A
				X Walk 1 Slope (%)	3.8		X Walk 2 Slope (%)	5.8
				X Walk 1 X Slope (%)	3.8		X Walk 2 X Slope (%)	5.5
			N/A	Ramp inside XWalk1?	N/A	N/A	Ramp inside XWalk2?	N/A
Stop Condition-Street 2				Road Slope (%)	0.7	N/A	Clear Space?	N/A
	Street 2 Name			Road X Slope (%)	4.5	N/A	Clear Space to XWalk (in)	N/A
	Mallen Dr		N/A	Any Obstructions?	N/A	N/A	Storm Grate/Utility Hazard?	N/A
	Stop Condition-Street 1			Obstruction Type			Storm Grate/Utility Type	
	None				N/A			N/A
						Yes	Surface Condition? (G/P)	Good
Total Cost:		\$	3200.00
