Access Compliance Report

Public Rights-of-Way

(Curb Ramps)

Intersection ID: 28715	Main Street: EAGLE_CREEK_DR	Cross Street: DELAMERE_LN	Location:	N
ADA ID: DFC5716325E4	Ramp Type: PerpDiag	Initial Pass/Fail: Fail	Overall Compliance: No	Severity Score: 12.5

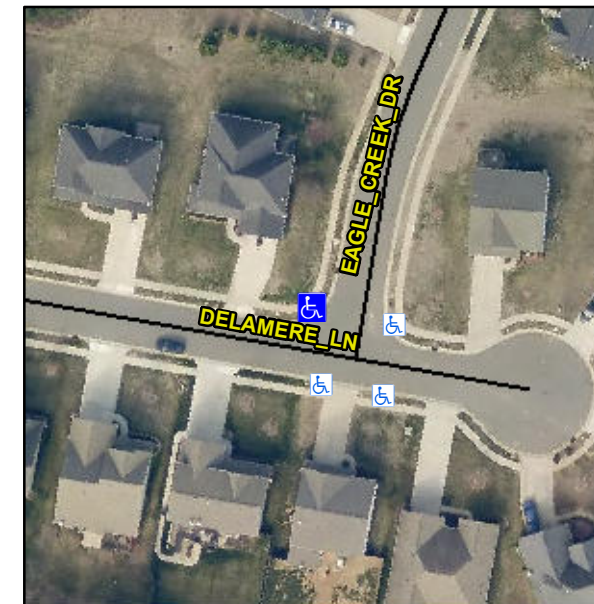
Not Found, R304.2.2

Compliance	Description	Data	Compliance	Description	Data
N/A	Ramp Length (in)	48.0	No	Ramp Slope (%)	11.2
Yes	Ramp Width (in)	48.0	Yes	Ramp XSlope (%)	1.0
N/A	Flare Type LT	N/A	N/A	Flare Type RT	N/A
N/A	Flare Slope LT (%)	N/A	N/A	Flare Slope RT (%)	N/A
N/A	Flare Traversable LT?	N/A	N/A	Flare Traversable RT?	N/A
N/A	Landing Length (in)	N/A	N/A	DWS Provided?	N/A
N/A	Landing Width (in)	N/A	N/A	DWS Contrast?	N/A
N/A	Landing Slope (%)	N/A	N/A	DWS Length (in)	N/A
N/A	Landing X Slope (%)	N/A	N/A	DWS Full Width?	N/A
N/A	Landing Curb? (Y/N)	N/A	N/A	DWS Offset (in)	N/A
N/A	Shared Landing?	N/A			
N/A	Gutter Ponding?	N/A	N/A	Gutter Slope (%)	N/A
N/A	Gutter Lip Ht (in)	N/A	N/A	Gutter X Slope (%)	N/A
N/A	Painted X Walk1?	No	N/A	Painted X Walk2?	No
	X Walk 1 Direction	To S		X Walk 2 Direction	To E
N/A	X Walk 1 Width (in)	N/A	N/A	X Walk 2 Width (in)	N/A
	X Walk 1 Slope (%)	1.9		X Walk 2 Slope (%)	2.7
	X Walk 1 X Slope (%)	2.1		X Walk 2 X Slope (%)	2.9

N/A	Ramp inside XWalk1?	N/A	N/A	Ramp inside XWalk2?	N/A
	Road Slope (%)	0.3	N/A	Clear Space?	N/A
	Road X Slope (%)	3.7	N/A	Clear Space to XWalk (in)	N/A
N/A	Any Obstructions?	N/A	N/A	Storm Grate/Utility Hazard?	N/A
	Obstruction Type			Storm Grate/Utility Type	
		N/A			N/A
			Yes	Surface Condition? (G/P)	Good

Possible Solutions:

Remove & Replace Curb Ramp With Two New Directional Ramps or Equivalent.
