# Access Compliance Report

## Public Rights-of-Way

### (Curb Ramps)

Intersection ID: 9189	Main Street: DRUID_CR	Cross Street: STATESVILLE_AV	Location: NE
ADA ID: DFCB567560F1	Ramp Type: Directional1	Initial Pass/Fail: Pass	Overall Compliance: No
Severity Score: 2.5			
Codes/Mitigation Info/Possible Solution		Field Measurements/Component Compliance

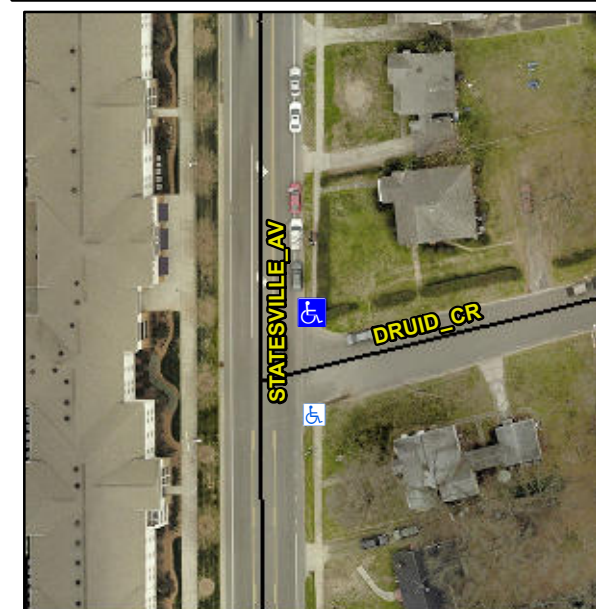
**VEGETATION OVERGROWTH**

Compliance	Description	Data	Compliance	Description	Data
N/A	Ramp Length (in)	59.5	Yes	Grade Break?	Yes
Yes	Ramp Width (in)	63.0	Yes	Grade Break Slope (%)	1.1
Yes	Ramp Slope (%)	4.1	No	Grade Break XSlope (%)	4.3
Yes	Ramp XSlope (%)	2.0			
Yes	Flare Type LT	N/A	Yes	Flare Type RT	N/A
N/A	Flare Slope LT (%)	N/A	N/A	Flare Slope RT (%)	N/A
N/A	Flare Traversable LT?	No	N/A	Flare Traversable RT?	No
Yes	Landing Length (in)	59.0	Yes	DWS Provided?	Yes
Yes	Landing Width (in)	63.0	Yes	DWS Contrast?	Yes
Yes	Landing Slope (%)	0.3	Yes	DWS Length (in)	25.0
Yes	Landing X Slope (%)	1.1	No	DWS Full Width?	No
N/A	Landing Curb? (Y/N)	No	Yes	DWS Offset LT (in)	0.0
N/A	Shared Landing?	No	Yes	DWS Offset RT (in)	55.0
No	Gutter Ponding?	Yes	Yes	Gutter Slope (%)	2.1
Yes	Gutter Lip Ht (in)	0.0	Yes	Gutter X Slope (%)	0.7
N/A	Painted X Walk1?	No		Road Slope (%)	1.1
	X Walk 1 Direction	To S		Road X Slope (%)	0.1
	X Walk 1 Width (in)	N/A		Clear Space?	Yes

X Walk 1 Slope (%)	1.1	N/A	Clear Space to XWalk (in)	N/A
	X Walk 1 X Slope (%)	0.1	Yes	Storm Grate/Utility Hazard?	No
N/A	Ramp inside XWalk1?	N/A		Storm Grate/Utility Type	
Yes	Any Obstructions?	No			N/A
	Obstruction Type		Yes	Surface Condition? (G/P)	Good
			N/A	Curb Slope (%)	N/A

**Remove & Replace Entire Ramp.  
Gutter Ponding Observed.**

**R304.5.3, R305.1.4, R302.7**
