# Access Compliance Report

## Public Rights-of-Way

### (Curb Ramps)

| Intersection ID: 32240 | Main Street: RICHPORT_DR | Cross Street: WESTGARTH_AV | Location: W |

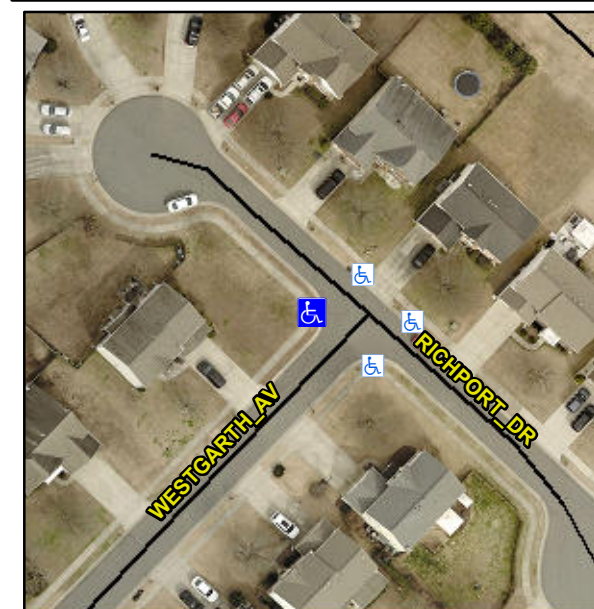
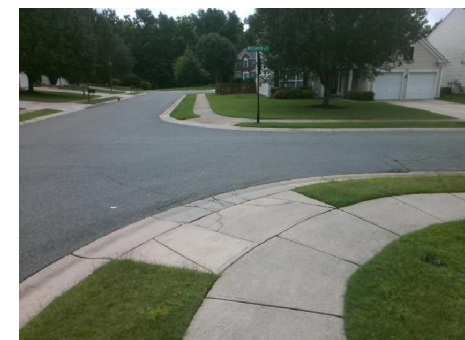
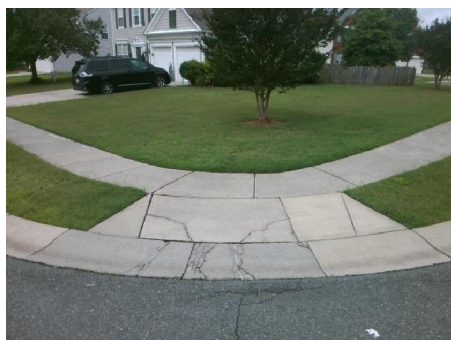
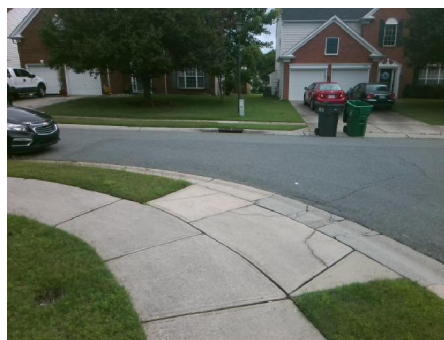
**DAMAGED GTR**

**Not Found, R304.5.3, R304.2.1, R305, R304.5.4**

| Compliance | Description | Data | Compliance | Description | Data |
|---|---|---|---|---|---|
| Yes | Ramp Width (in) | 67.0 | No | BlendTrans XSlope (%) | 3.7 |
| No | Landing Length (in) | 46.0 | No | DWS Provided? | No |
| No | Landing X Slope (%) | 2.5 | N/A | DWS Full Width? | No |
| Yes | Gutter Ponding? | No | No | Gutter Slope (%) | 7.5 |
| Yes | Gutter Lip Ht (in) | 0.0 | No | Gutter X Slope (%) | 4.9 |

**Remove & Replace Curb Ramp With Two New Directional Ramps or Equivalent. Remove & Replace Gutter.**
