Access Compliance Report

Public Rights-of-Way

(Curb Ramps)

Intersection ID: 42513	Main Street: ELM_LN	Cross Street: INDIGO_RW	Location:	N
ADA ID: DFD17414CA1B	Ramp Type: Perp	Initial Pass/Fail: Fail	Overall Compliance: No	Severity Score: 8.75
Codes/Mitigation Info/Possible Solution		Field Measurements/Component Compliance

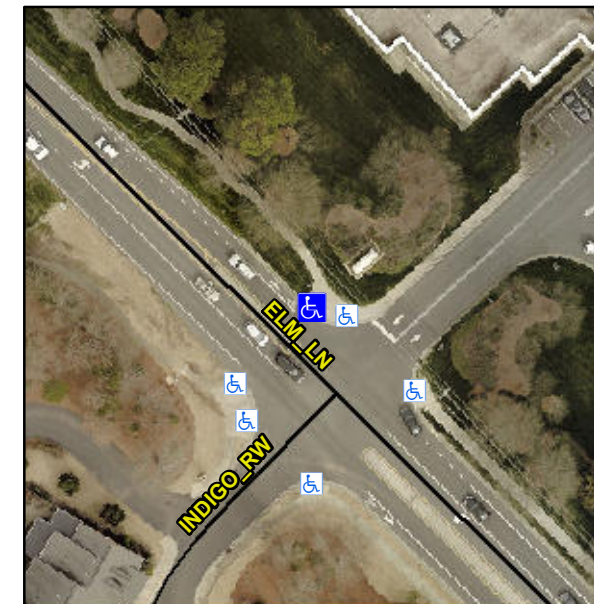
Not Found, R304.5.1

Compliance	Description	Data	Compliance	Description	Data
N/A	Ramp Length (in)	114.0	Yes	Ramp Slope (%)	5.8
No	Ramp Width (in)	45.5	Yes	Ramp XSlope (%)	0.5
N/A	Flare Type LT	N/A	N/A	Flare Type RT	N/A
N/A	Flare Slope LT (%)	N/A	N/A	Flare Slope RT (%)	N/A
N/A	Flare Traversable LT?	N/A	N/A	Flare Traversable RT?	N/A
N/A	Landing Length (in)	N/A	N/A	DWS Provided?	N/A
N/A	Landing Width (in)	N/A	N/A	DWS Contrast?	N/A
N/A	Landing Slope (%)	N/A	N/A	DWS Length (in)	N/A
N/A	Landing X Slope (%)	N/A	N/A	DWS Full Width?	N/A
N/A	Landing Curb? (Y/N)	N/A	N/A	DWS Offset (in)	N/A
N/A	Shared Landing?	N/A			
N/A	Gutter Ponding?	N/A	N/A	Gutter Slope (%)	N/A
N/A	Gutter Lip Ht (in)	N/A	N/A	Gutter X Slope (%)	N/A
N/A	Painted X Walk1?	No	N/A	Painted X Walk2?	N/A
	X Walk 1 Direction	To SW		X Walk 2 Direction	N/A
N/A	X Walk 1 Width (in)	N/A	N/A	X Walk 2 Width (in)	N/A
	X Walk 1 Slope (%)	3.3		X Walk 2 Slope (%)	N/A
	X Walk 1 X Slope (%)	2.6		X Walk 2 X Slope (%)	N/A

N/A	Ramp inside XWalk1?	N/A	N/A	Ramp inside XWalk2?	N/A
	Road Slope (%)	N/A	N/A	Clear Space?	N/A
	Road X Slope (%)	N/A	N/A	Clear Space to XWalk (in)	N/A
N/A	Any Obstructions?	N/A	N/A	Storm Grate/Utility Hazard?	N/A
	Obstruction Type			Storm Grate/Utility Type	
		N/A			N/A
			Yes	Surface Condition? (G/P)	Good

Remove & Replace Entire Ramp.

Total Cost: \$ 1850.00
