# Access Compliance Report

## Public Rights-of-Way

### (Curb Ramps)

Intersection ID: 12761	Main Street: S_MINT_ST	Cross Street: W_CARSON_BV	Location: S
ADA ID: DFDCC94360A8	Ramp Type: PerpDiag	Initial Pass/Fail: Fail	Overall Compliance: No
Severity Score: 25			
Codes/Mitigation Info/Possible Solution		Field Measurements/Component Compliance

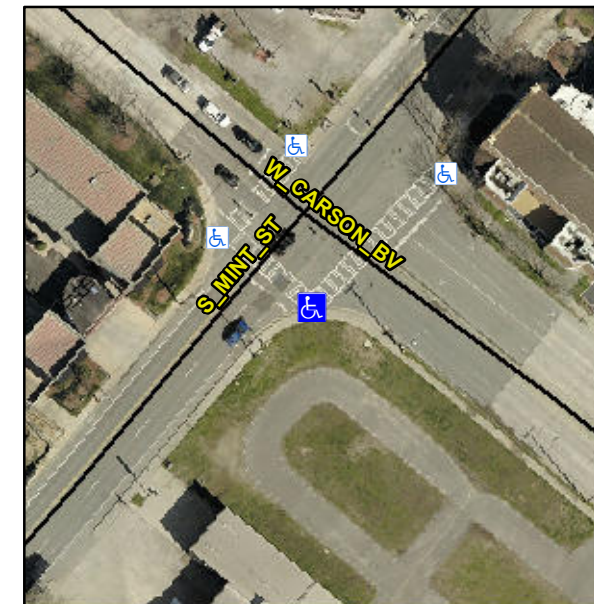
Compliance	Description	Data	Compliance	Description	Data
N/A	Ramp Length (in)	58.0	No	Ramp Slope (%)	8.9
Yes	Ramp Width (in)	48.0	No	Ramp XSlope (%)	5.6
N/A	Flare Type LT	N/A	N/A	Flare Type RT	N/A
N/A	Flare Slope LT (%)	N/A	N/A	Flare Slope RT (%)	N/A
N/A	Flare Traversable LT?	N/A	N/A	Flare Traversable RT?	N/A
N/A	Landing Length (in)	N/A	N/A	DWS Provided?	N/A
N/A	Landing Width (in)	N/A	N/A	DWS Contrast?	N/A
N/A	Landing Slope (%)	N/A	N/A	DWS Length (in)	N/A
N/A	Landing X Slope (%)	N/A	N/A	DWS Full Width?	N/A
N/A	Landing Curb? (Y/N)	N/A	N/A	DWS Offset (in)	N/A
N/A	Shared Landing?	N/A			
N/A	Gutter Ponding?	N/A	N/A	Gutter Slope (%)	N/A
N/A	Gutter Lip Ht (in)	N/A	N/A	Gutter X Slope (%)	N/A
N/A	Painted X Walk1?	Yes	N/A	Painted X Walk2?	Yes
	X Walk 1 Direction	To NE		X Walk 2 Direction	To NW
N/A	X Walk 1 Width (in)	108.0	N/A	X Walk 2 Width (in)	104.0
	X Walk 1 Slope (%)	1.4		X Walk 2 Slope (%)	3.5
	X Walk 1 X Slope (%)	3.0		X Walk 2 X Slope (%)	2.3

N/A	Ramp inside XWalk1?	Yes	N/A	Ramp inside XWalk2?	Yes
	Road Slope (%)	1.1	N/A	Clear Space?	N/A
	Road X Slope (%)	5.2	N/A	Clear Space to XWalk (in)	N/A
N/A	Any Obstructions?	N/A	N/A	Storm Grate/Utility Hazard?	N/A
	Obstruction Type			Storm Grate/Utility Type	
		N/A			N/A
		Yes		Surface Condition? (G/P)	Good

Possible Solutions:

**Remove & Replace Curb Ramp With Two New Directional Ramps or Equivalent.**

**R304.2.2, R304.5.3**
