Access Compliance Report

Public Rights-of-Way

(Curb Ramps)

Intersection ID: 43146	Main Street: EASTWAY_DR	Cross Street: EASTWAY_DR_RA	Location: SW
ADA ID: DFE23E09B8A8	Ramp Type: Perp	Initial Pass/Fail: Fail	Overall Compliance: No
Severity Score: 46.25			
Codes/Mitigation Info/Possible Solution		Field Measurements/Component Compliance

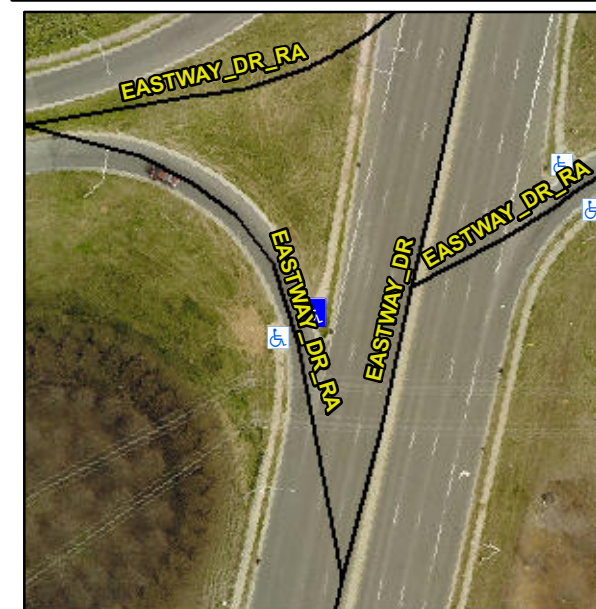
Not Found, R304.5.1, R304.2.2, R304.5.3

Compliance	Description	Data	Compliance	Description	Data
N/A	Ramp Length (in)	37.0	No	Ramp Slope (%)	13.8
No	Ramp Width (in)	40.0	No	Ramp XSlope (%)	5.6
N/A	Flare Type LT	N/A	N/A	Flare Type RT	N/A
N/A	Flare Slope LT (%)	N/A	N/A	Flare Slope RT (%)	N/A
N/A	Flare Traversable LT?	N/A	N/A	Flare Traversable RT?	N/A
N/A	Landing Length (in)	N/A	N/A	DWS Provided?	N/A
N/A	Landing Width (in)	N/A	N/A	DWS Contrast?	N/A
N/A	Landing Slope (%)	N/A	N/A	DWS Length (in)	N/A
N/A	Landing X Slope (%)	N/A	N/A	DWS Full Width?	N/A
N/A	Landing Curb? (Y/N)	N/A	N/A	DWS Offset (in)	N/A
N/A	Shared Landing?	N/A			
N/A	Gutter Ponding?	N/A	N/A	Gutter Slope (%)	N/A
N/A	Gutter Lip Ht (in)	N/A	N/A	Gutter X Slope (%)	N/A
N/A	Painted X Walk1?	No	N/A	Painted X Walk2?	N/A
	X Walk 1 Direction	To S		X Walk 2 Direction	N/A
N/A	X Walk 1 Width (in)	N/A	N/A	X Walk 2 Width (in)	N/A
	X Walk 1 Slope (%)	5.2		X Walk 2 Slope (%)	N/A
	X Walk 1 X Slope (%)	3.3		X Walk 2 X Slope (%)	N/A

N/A	Ramp inside XWalk1?	N/A	N/A	Ramp inside XWalk2?	N/A
	Road Slope (%)	N/A	N/A	Clear Space?	N/A
	Road X Slope (%)	N/A	N/A	Clear Space to XWalk (in)	N/A
N/A	Any Obstructions?	N/A	N/A	Storm Grate/Utility Hazard?	N/A
	Obstruction Type			Storm Grate/Utility Type	
		N/A			N/A
			Yes	Surface Condition? (G/P)	Good

Possible Solutions:

Remove & Replace Entire Ramp.
