Access Compliance Report

Public Rights-of-Way

(Curb Ramps)

Intersection ID: 4758	Main Street: ARKLOW_RD	Cross Street: BEAKER_CT	Location:	E
ADA ID: DFE33CD7B80F	Ramp Type: Perp	Initial Pass/Fail: Fail	Overall Compliance: No	Severity Score: 26.25

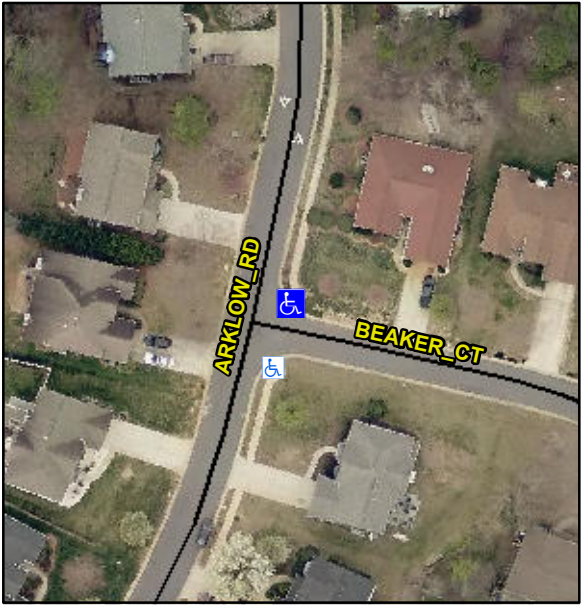
Possible Solutions:		Compliance	Description	Data
	Remove & Replace Entire Ramp.		N/A	Ramp Length (in)	48.5
			Yes	Ramp Width (in)	54.0
			N/A	Flare Type LT	N/A
			N/A	Flare Slope LT (%)	N/A
			N/A	Flare Traversable LT?	N/A
			N/A	Landing Length (in)	N/A
			N/A	Landing Width (in)	N/A
			N/A	Landing Slope (%)	N/A
			N/A	Landing X Slope (%)	N/A
<p>Surveyor Notes:</p> <p>N/A</p> <p>PROW/ADA:</p> <p>Not Found, R304.2.2, R304.5.3</p>			N/A	Flare Type RT	N/A
			N/A	Flare Slope RT (%)	N/A
			N/A	Flare Traversable RT?	N/A
			N/A	DWS Provided?	N/A
			N/A	DWS Contrast?	N/A
			N/A	DWS Length (in)	N/A
			N/A	DWS Full Width?	N/A
			N/A	DWS Offset (in)	N/A
			N/A	Shared Landing?	N/A
			N/A	Gutter Ponding?	N/A
			N/A	Gutter Lip Ht (in)	N/A
			N/A	Painted X Walk1?	No
				X Walk 1 Direction	To SW
			N/A	X Walk 1 Width (in)	N/A
				X Walk 1 Slope (%)	9.4

X Walk 1 X Slope (%)	0.8
			N/A	Ramp inside XWalk1?	N/A
			N/A	Road Slope (%)	N/A
			N/A	Road X Slope (%)	N/A
			N/A	Any Obstructions?	N/A
				Obstruction Type	
Total Cost:		\$ 1850.00			
			N/A		N/A
			Yes	Surface Condition? (G/P)	Good
