Access Compliance Report

Public Rights-of-Way

(Curb Ramps)

Intersection ID: 23784	Main Street: E WESTINGHOUSE BV	Cross Street: NATIONS_FORD_RD	Location: E
ADA ID: DFE43DE0CF6F	Ramp Type: Perp	Initial Pass/Fail: Fail	Overall Compliance: No
		Severity Score: 10

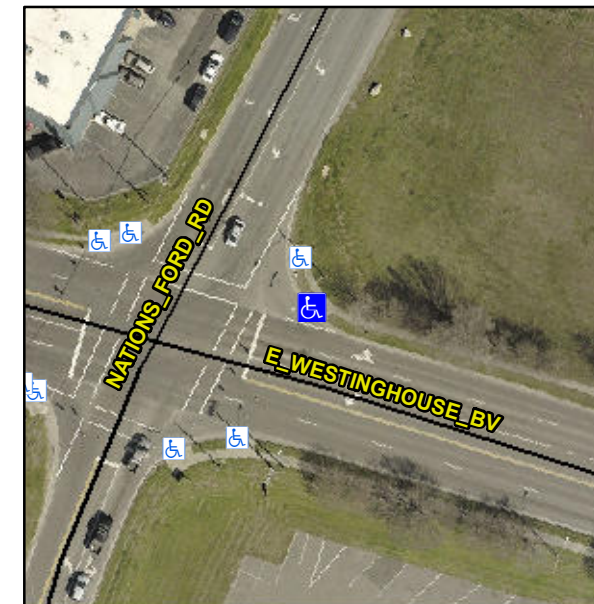
Not Found, R304.5.1, R304.5.3

Compliance	Description	Data	Compliance	Description	Data
N/A	Ramp Length (in)	113.0	Yes	Ramp Slope (%)	6.2
No	Ramp Width (in)	43.0	No	Ramp XSlope (%)	2.1
N/A	Flare Type LT	N/A	N/A	Flare Type RT	N/A
N/A	Flare Slope LT (%)	N/A	N/A	Flare Slope RT (%)	N/A
N/A	Flare Traversable LT?	N/A	N/A	Flare Traversable RT?	N/A
N/A	Landing Length (in)	N/A	N/A	DWS Provided?	N/A
N/A	Landing Width (in)	N/A	N/A	DWS Contrast?	N/A
N/A	Landing Slope (%)	N/A	N/A	DWS Length (in)	N/A
N/A	Landing X Slope (%)	N/A	N/A	DWS Full Width?	N/A
N/A	Landing Curb? (Y/N)	N/A	N/A	DWS Offset (in)	N/A
N/A	Shared Landing?	N/A			
N/A	Gutter Ponding?	N/A	N/A	Gutter Slope (%)	N/A
N/A	Gutter Lip Ht (in)	N/A	N/A	Gutter X Slope (%)	N/A
N/A	Painted X Walk1?	Yes	N/A	Painted X Walk2?	N/A
	X Walk 1 Direction	To SW		X Walk 2 Direction	N/A
N/A	X Walk 1 Width (in)	96.0	N/A	X Walk 2 Width (in)	N/A
	X Walk 1 Slope (%)	4.3		X Walk 2 Slope (%)	N/A
	X Walk 1 X Slope (%)	0.3		X Walk 2 X Slope (%)	N/A

N/A	Ramp inside XWalk1?	No	N/A	Ramp inside XWalk2?	N/A
	Road Slope (%)	N/A	N/A	Clear Space?	N/A
	Road X Slope (%)	N/A	N/A	Clear Space to XWalk (in)	N/A
N/A	Any Obstructions?	N/A	N/A	Storm Grate/Utility Hazard?	N/A
	Obstruction Type			Storm Grate/Utility Type	
		N/A			N/A
			Yes	Surface Condition? (G/P)	Good

**Remove & Replace Entire Ramp.
Restripe Crosswalk.**
