## Access Compliance Report Public Rights-of-Way (Curb Ramps)

Intersection ID: 16735 Main Street: JAMESTON\_DR Cross Street: PRINCETON\_AV Location: SW

ADA ID: DFEB2DDB1FBF Ramp Type: PerpDiag Initial Pass/Fail: Fail Overall Compliance: No Severity Score: 13.75

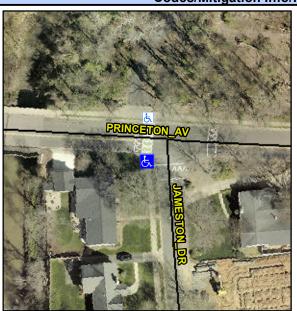
Not Found, R304.2.2, R304.5.3

Field Measurements/Component Compliance							
	Compliance Description		Data	Compliance		Description	Data
	N/A	Ramp Length (in)	74.0	No	Ramp	Slope (%)	9.1
	Yes	Ramp Width (in)	48.0	No	Ramp	XSlope (%)	2.2
	N/A	Flare Type LT	N/A	N/A	Flare	Type RT	N/A
	N/A	Flare Slope LT (%)	N/A	N/A	Flare	Slope RT (%)	N/A
	N/A	Flare Traversable LT?	N/A	N/A	Flare	Traversable RT?	N/A
	N/A	Landing Length (in)	N/A	N/A	DWS	Provided?	N/A
	N/A	Landing Width (in)	N/A	N/A	DWS	Contrast?	N/A
	N/A	Landing Slope (%)	N/A	N/A	DWS	Length (in)	N/A
	N/A	Landing X Slope (%)	N/A	N/A	DWS	Full Width?	N/A
	N/A	Landing Curb? (Y/N)	N/A	N/A	DWS	Offset (in)	N/A
	N/A	Shared Landing?	N/A				
	N/A	Gutter Ponding?	N/A	N/A	Gutte	er Slope (%)	N/A
	N/A	Gutter Lip Ht (in)	N/A	N/A	Gutte	er X Slope (%)	N/A
	N/A	Painted X Walk1?	No	N/A	Paint	ed X Walk2?	Yes
		X Walk 1 Direction	ТоЕ		X Wa	lk 2 Direction	To NE
	N/A	X Walk 1 Width (in)	N/A	N/A	X Wa	lk 2 Width (in)	121.0

X Walk 1 Slope (%)	3.1		X Wa	lk 2 Slope (%)	7.2
		X Walk 1 X Slope (%)	7.7		X Wa	lk 2 X Slope (%)	5.2
	N/A	Ramp inside XWalk1?	N/A	N/A	Ram	o inside XWalk2?	Yes
		Road Slope (%)	1.4	N/A	Clear	Space?	N/A
		Road X Slope (%)	8.2	N/A	Clear	Space to XWalk (in)	N/A
	N/A	Any Obstructions?	N/A	N/A	Storn	n Grate/Utility Hazard?	N/A
		Obstruction Type			Storn	n Grate/Utility Type	
			N/A				N/A
				Yes	Surfa	ce Condition? (G/P)	Good

Remove & Replace Curb Ramp With Two New Directional Ramps or Equivalent.
