# Access Compliance Report

## Public Rights-of-Way

### (Curb Ramps)

Intersection ID: 25420	Main Street: MCPHERSON_DR	Cross Street: WYMAN_LN	Location: SW
ADA ID: DFEE539DDC9F	Ramp Type: Directional1	Initial Pass/Fail: Fail	Overall Compliance: No
Codes/Mitigation Info/Possible Solution		Field Measurements/Component Compliance	
Severity Score: 10

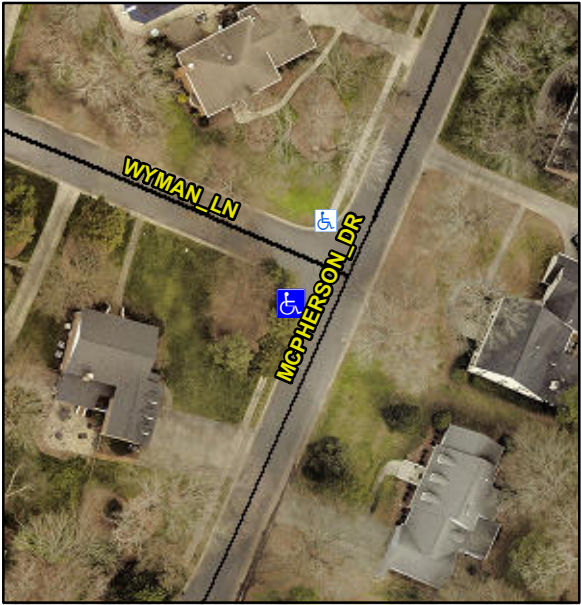
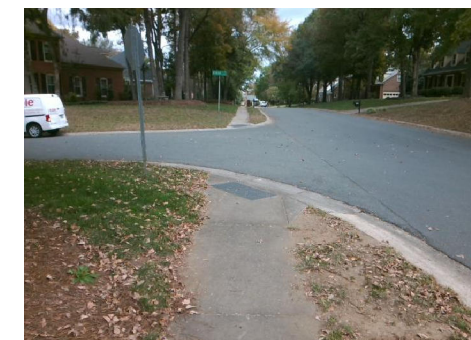
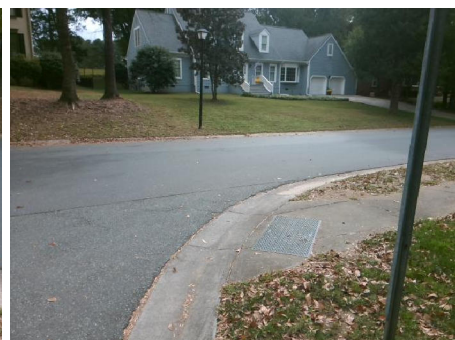
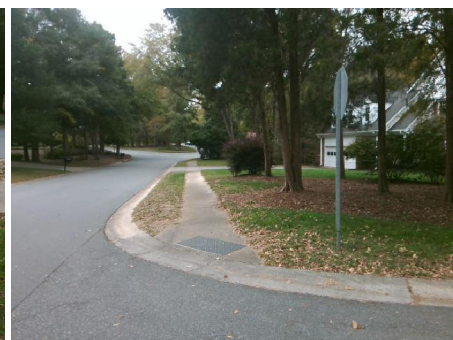
Possible Solutions:				
	Remove & Replace Entire Ramp.				
	Surveyor Notes:				
	N/A				
	PROW/ADA:				
	R304.5.1, R304.5.3				
	Street 1 Name	WYMAN LN			
	Stop Condition-Street 1	StopSign			
	Street 2 Name	N/A			
	Stop Condition-Street 2	N/A			
Total Cost:		\$	1600.00		
		Compliance	Description	Data	Compliance Description Data
		N/A	Ramp Length (in)	64.0	N/A Grade Break? N/A
		No	Ramp Width (in)	42.0	N/A Grade Break Slope (%) 0.0
		Yes	Ramp Slope (%)	1.4	N/A Grade Break XSlope (%) 0.0
		No	Ramp XSlope (%)	2.3	
		N/A	Flare Type LT	N/A	N/A Flare Type RT N/A
		N/A	Flare Slope LT (%)	N/A	N/A Flare Slope RT (%) 0.0
		N/A	Flare Traversable LT?	N/A	N/A Flare Traversable RT? N/A
		N/A	Landing Length (in)	0.0	N/A DWS Provided? N/A
		N/A	Landing Width (in)	0.0	N/A DWS Contrast? N/A
		N/A	Landing Slope (%)	0.0	N/A DWS Length (in) N/A
		N/A	Landing X Slope (%)	0.0	N/A DWS Full Width? N/A
		N/A	Landing Curb? (Y/N)	N/A	N/A DWS Offset LT (in) N/A

N/A	Shared Landing?	N/A	N/A DWS Offset RT (in) N/A
		N/A	Gutter Ponding?	0.0	N/A Gutter Slope (%) N/A
		N/A	Gutter Lip Ht (in)	0.0	N/A Gutter X Slope (%) N/A
		N/A	Painted X Walk1?	No	Road Slope (%) 1.7
			X Walk 1 Direction	To NE	Road X Slope (%) 1.3
			X Walk 1 Width (in)	N/A	Clear Space? N/A
			X Walk 1 Slope (%)	1.7	N/A Clear Space to XWalk (in) N/A
			X Walk 1 X Slope (%)	1.3	N/A Storm Grate/Utility Hazard? N/A
		N/A	Ramp inside XWalk1?	N/A	Storm Grate/Utility Type
		N/A	Any Obstructions?	N/A	N/A
			Obstruction Type		Yes Surface Condition? (G/P) Good
				N/A	N/A Curb Slope (%) 11.6
