Access Compliance Report

Public Rights-of-Way

(Curb Ramps)

Intersection ID: 13685	Main Street: S_MINT_ST	Cross Street: W_WORTHINGTON_AV	Location: NW
ADA ID: DFF467664EDC	Ramp Type: PerpDiag	Initial Pass/Fail: Fail	Overall Compliance: No
Severity Score: 33.75			
Codes/Mitigation Info/Possible Solution		Field Measurements/Component Compliance

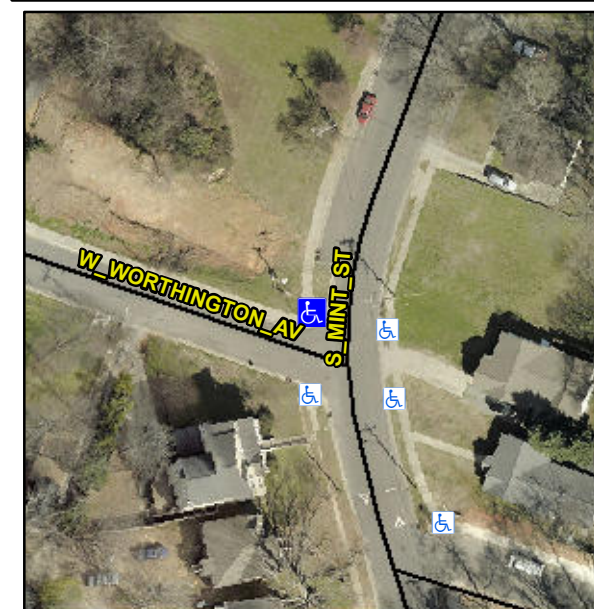
Not Found, R304.5.1, R304.5.3

Compliance	Description	Data	Compliance	Description	Data
N/A	Ramp Length (in)	59.0	Yes	Ramp Slope (%)	6.8
No	Ramp Width (in)	37.5	No	Ramp XSlope (%)	8.5
N/A	Flare Type LT	N/A	N/A	Flare Type RT	N/A
N/A	Flare Slope LT (%)	N/A	N/A	Flare Slope RT (%)	N/A
N/A	Flare Traversable LT?	N/A	N/A	Flare Traversable RT?	N/A
N/A	Landing Length (in)	N/A	N/A	DWS Provided?	N/A
N/A	Landing Width (in)	N/A	N/A	DWS Contrast?	N/A
N/A	Landing Slope (%)	N/A	N/A	DWS Length (in)	N/A
N/A	Landing X Slope (%)	N/A	N/A	DWS Full Width?	N/A
N/A	Landing Curb? (Y/N)	N/A	N/A	DWS Offset (in)	N/A
N/A	Shared Landing?	N/A			
N/A	Gutter Ponding?	N/A	N/A	Gutter Slope (%)	N/A
N/A	Gutter Lip Ht (in)	N/A	N/A	Gutter X Slope (%)	N/A
N/A	Painted X Walk1?	No	N/A	Painted X Walk2?	No
	X Walk 1 Direction	To S		X Walk 2 Direction	To SE
N/A	X Walk 1 Width (in)	N/A	N/A	X Walk 2 Width (in)	N/A
	X Walk 1 Slope (%)	5.9		X Walk 2 Slope (%)	1.2
	X Walk 1 X Slope (%)	6.8		X Walk 2 X Slope (%)	3.1

N/A	Ramp inside XWalk1?	N/A	N/A	Ramp inside XWalk2?	N/A
	Road Slope (%)	3.4	N/A	Clear Space?	N/A
	Road X Slope (%)	1.5	N/A	Clear Space to XWalk (in)	N/A
N/A	Any Obstructions?	N/A	N/A	Storm Grate/Utility Hazard?	N/A
	Obstruction Type			Storm Grate/Utility Type	
		N/A			N/A
		Yes		Surface Condition? (G/P)	Good

Possible Solutions:

Remove & Replace Curb Ramp With Two New Directional Ramps or Equivalent.
