# Access Compliance Report

## Public Rights-of-Way

### (Curb Ramps)

Intersection ID: 10574	Main Street: ACADEMY_ST	Cross Street: THE_PLAZA	Location: NW
ADA ID: DFFB16EBB3A6	Ramp Type: Combination1	Initial Pass/Fail: Fail	Overall Compliance: No
		Severity Score: 8.75

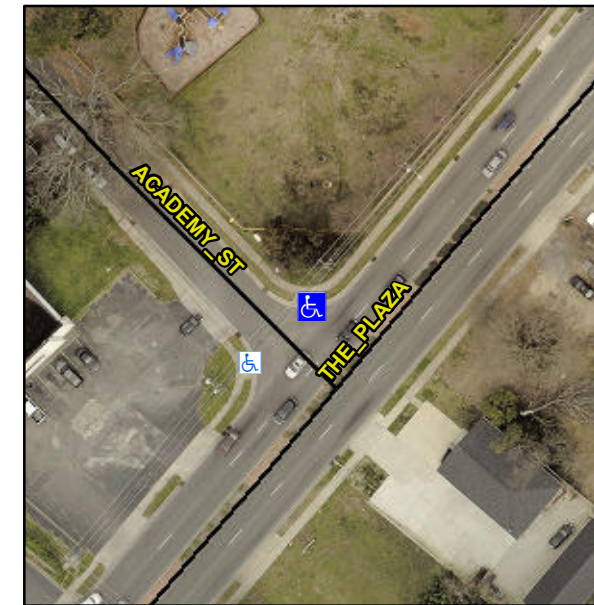
**RT RP < 5%**

**Not Found, R304.5.1**

Compliance	Description	Data	Compliance	Description	Data
N/A	Ramp Length LT (in)	51.0	N/A	Ramp Length RT (in)	41.0
Yes	Ramp Width LT (in)	59.0	Yes	Ramp Width RT (in)	60.5
Yes	Ramp Slope LT (%)	5.2	Yes	Ramp Slope RT (%)	3.4
Yes	Ramp XSlope LT (%)	1.2	Yes	Ramp XSlope RT (%)	0.9
N/A	Ramp Length (in)	47.5	Yes	Ramp Slope (%)	5.3
No	Ramp Width (in)	44.0	Yes	Ramp XSlope (%)	0.4
N/A	Flare Type LT	N/A	N/A	Flare Type RT	N/A
N/A	Flare Slope LT (%)	N/A	N/A	Flare Slope RT (%)	N/A
N/A	Flare Traversable LT?	N/A	N/A	Flare Traversable RT?	N/A
N/A	Landing Length (in)	N/A	N/A	DWS Provided?	N/A
N/A	Landing Width (in)	N/A	N/A	DWS Contrast?	N/A
N/A	Landing Slope (%)	N/A	N/A	DWS Length (in)	N/A
N/A	Landing X Slope (%)	N/A	N/A	DWS Full Width?	N/A
N/A	Landing Curb? (Y/N)	N/A	N/A	DWS Offset (in)	N/A
N/A	Shared Landing?	N/A			
N/A	Gutter Ponding?	N/A	N/A	Gutter Slope (%)	N/A
N/A	Gutter Lip Ht (in)	N/A	N/A	Gutter X Slope (%)	N/A
N/A	Painted X Walk1?	No	N/A	Painted X Walk2?	N/A

X Walk 1 Direction	To SW		X Walk 2 Direction	N/A
	X Walk 1 Width (in)	N/A		X Walk 2 Width (in)	N/A
	X Walk 1 Slope (%)	1.3		X Walk 2 Slope (%)	N/A
	X Walk 1 X Slope (%)	1.5		X Walk 2 X Slope (%)	N/A
N/A	Ramp inside XWalk1?	N/A	N/A	Ramp inside XWalk2?	N/A
	Road Slope (%)	N/A		Clear Space?	N/A
	Road X Slope (%)	N/A	N/A	Clear Space to XWalk (in)	N/A
			N/A	Any Obstruction?	N/A
				Obstruction Type	N/A
			N/A	Storm Grate/Utility Hazard?	N/A
				Storm Grate/Utility Type	N/A
			Yes	Surface Condition? (G/P)	Good
				Curb Slope (%)	16.0

**Remove & Replace Entire Ramp.**
