Access Compliance Report

Public Rights-of-Way

(Curb Ramps)

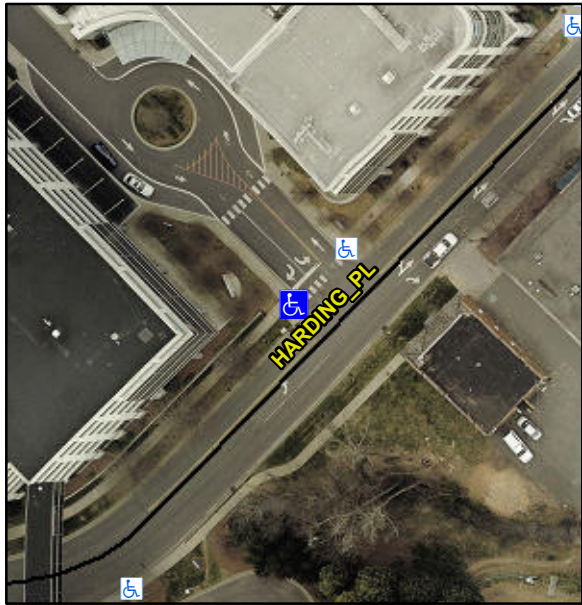
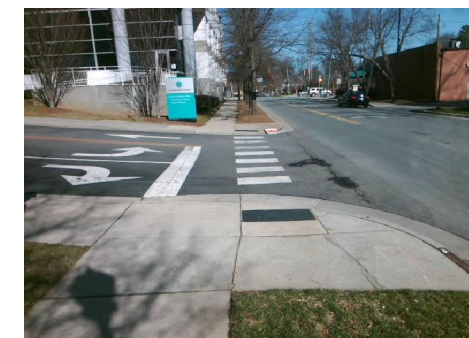
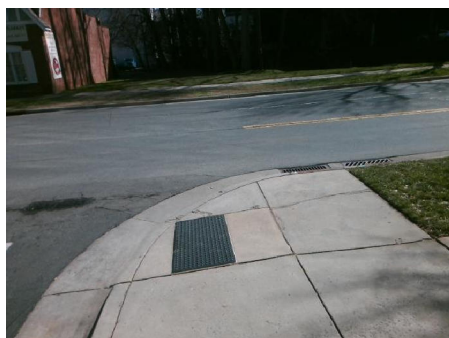
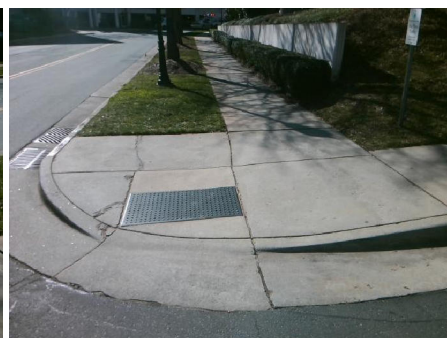
Intersection ID: 10027951		Main Street: HARDING_PL		Cross Street: N/A		Location: SW							
ADA ID: E0014F79805C		Ramp Type: Directional1		Initial Pass/Fail: Fail		Overall Compliance: No		Severity Score: 12.5					
Codes/Mitigation Info/Possible Solution				Field Measurements/Component Compliance

Possible Solutions:		Compliance		Description		Data			
				Remove & Replace Entire Ramp.		N/A	Ramp Length (in)	49.0		N/A	Grade Break?	N/A	
Surveyor Notes:				N/A		Yes	Ramp Width (in)	48.0		N/A	Grade Break Slope (%)	0.0	
						No	Ramp Slope (%)	9.4		N/A	Grade Break XSlope (%)	0.0	
PROW/ADA:				R304.2.2		Yes	Ramp XSlope (%)	0.2		N/A	Flare Type LT	N/A	
						N/A	Flare Type RT	N/A		N/A	Flare Slope LT (%)	N/A	
						N/A	Flare Traversable LT?	N/A		N/A	Flare Traversable RT?	N/A	
						N/A	Landing Length (in)	0.0		N/A	DWS Provided?	N/A	
						N/A	Landing Width (in)	0.0		N/A	DWS Contrast?	N/A	
						N/A	Landing Slope (%)	0.0		N/A	DWS Length (in)	N/A

N/A	Landing X Slope (%)	0.0		N/A	DWS Full Width?	N/A	
						N/A	Landing Curb? (Y/N)	N/A		N/A	DWS Offset LT (in)	N/A	
						N/A	Shared Landing?	N/A		N/A	DWS Offset RT (in)	N/A	
						N/A	Gutter Ponding?	0.0		N/A	Gutter Slope (%)	N/A	
						N/A	Gutter Lip Ht (in)	0.0		N/A	Gutter X Slope (%)	N/A	
						N/A	Painted X Walk1?	Yes			Road Slope (%)	0.5	
							X Walk 1 Direction	To NE			Road X Slope (%)	1.2	
							X Walk 1 Width (in)	49.0			Clear Space?	N/A	
							X Walk 1 Slope (%)	0.5		N/A	Clear Space to XWalk (in)	N/A	
							X Walk 1 X Slope (%)	1.2		N/A	Storm Grate/Utility Hazard?	N/A	
						N/A	Ramp inside XWalk1?	Yes			Storm Grate/Utility Type		
						N/A	Any Obstructions?	N/A				N/A	
							Obstruction Type	Yes		Surface Condition? (G/P)	Good		
								N/A		N/A	Curb Slope (%)	13.3	
Total Cost:				\$	1600.00
