Access Compliance Report

Public Rights-of-Way

(Curb Ramps)

Intersection ID: 15882	Main Street: EAST_BV	Cross Street: QUEENS_RD_WEST	Location: SW
ADA ID: E001858D8B5E	Ramp Type: Directional1	Initial Pass/Fail: Fail	Overall Compliance: No
			Severity Score: 13.75

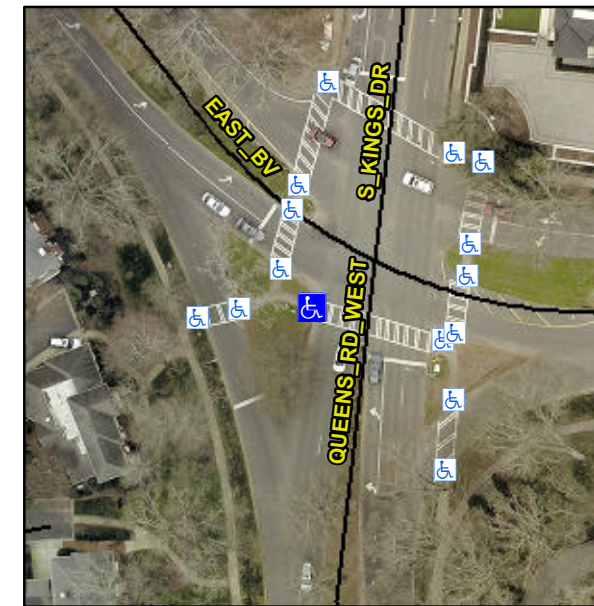
R304.2.2, R304.5.3

Compliance	Description	Data	Compliance	Description	Data
N/A	Ramp Length (in)	86.0	N/A	Grade Break?	N/A
Yes	Ramp Width (in)	51.0	N/A	Grade Break Slope (%)	0.0
No	Ramp Slope (%)	9.3	N/A	Grade Break XSlope (%)	0.0
No	Ramp XSlope (%)	3.1			
N/A	Flare Type LT	N/A	N/A	Flare Type RT	N/A
N/A	Flare Slope LT (%)	N/A	N/A	Flare Slope RT (%)	0.0
N/A	Flare Traversable LT?	N/A	N/A	Flare Traversable RT?	N/A
N/A	Landing Length (in)	0.0	N/A	DWS Provided?	N/A
N/A	Landing Width (in)	0.0	N/A	DWS Contrast?	N/A
N/A	Landing Slope (%)	0.0	N/A	DWS Length (in)	N/A
N/A	Landing X Slope (%)	0.0	N/A	DWS Full Width?	N/A
N/A	Landing Curb? (Y/N)	N/A	N/A	DWS Offset LT (in)	N/A
N/A	Shared Landing?	N/A	N/A	DWS Offset RT (in)	N/A
N/A	Gutter Ponding?	0.0	N/A	Gutter Slope (%)	N/A
N/A	Gutter Lip Ht (in)	0.0	N/A	Gutter X Slope (%)	N/A
N/A	Painted X Walk1?	Yes		Road Slope (%)	1.7
	X Walk 1 Direction	To SE		Road X Slope (%)	2.6
	X Walk 1 Width (in)	115.0		Clear Space?	N/A

X Walk 1 Slope (%)	1.7	N/A	Clear Space to XWalk (in)	N/A
	X Walk 1 X Slope (%)	2.6	N/A	Storm Grate/Utility Hazard?	N/A
N/A	Ramp inside XWalk1?	Yes		Storm Grate/Utility Type	
N/A	Any Obstructions?	N/A			N/A
	Obstruction Type		Yes	Surface Condition? (G/P)	Good
			N/A	Curb Slope (%)	2.0

Remove & Replace Entire Ramp.

Total Cost: \$ 1600.00
