Access Compliance Report

Public Rights-of-Way

(Curb Ramps)

Intersection ID: 13357	Main Street: FABER_ST	Cross Street: SEYMOUR_DR	Location: S
ADA ID: E002E39D9A25	Ramp Type: PerpDiag	Initial Pass/Fail: Fail	Overall Compliance: No
		Severity Score: 10

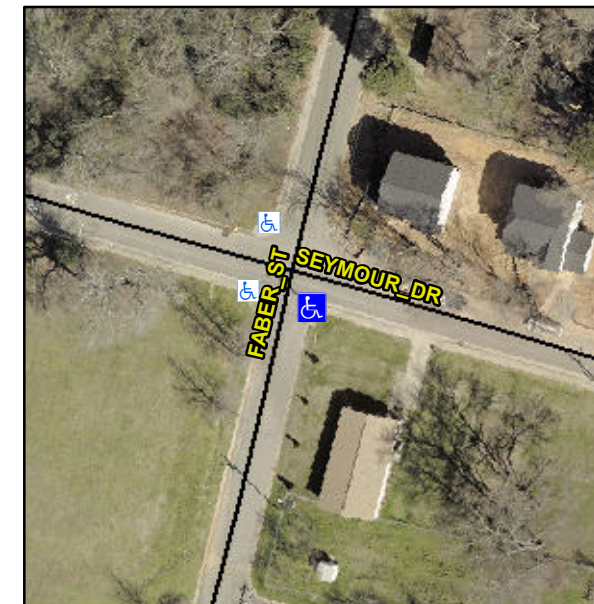
Not Found, R304.5.1, R304.5.3

Compliance	Description	Data	Compliance	Description	Data
N/A	Ramp Length (in)	44.0	Yes	Ramp Slope (%)	6.5
No	Ramp Width (in)	37.0	No	Ramp XSlope (%)	2.8
N/A	Flare Type LT	N/A	N/A	Flare Type RT	N/A
N/A	Flare Slope LT (%)	N/A	N/A	Flare Slope RT (%)	N/A
N/A	Flare Traversable LT?	N/A	N/A	Flare Traversable RT?	N/A
N/A	Landing Length (in)	N/A	N/A	DWS Provided?	N/A
N/A	Landing Width (in)	N/A	N/A	DWS Contrast?	N/A
N/A	Landing Slope (%)	N/A	N/A	DWS Length (in)	N/A
N/A	Landing X Slope (%)	N/A	N/A	DWS Full Width?	N/A
N/A	Landing Curb? (Y/N)	N/A	N/A	DWS Offset (in)	N/A
N/A	Shared Landing?	N/A			
N/A	Gutter Ponding?	N/A	N/A	Gutter Slope (%)	N/A
N/A	Gutter Lip Ht (in)	N/A	N/A	Gutter X Slope (%)	N/A
N/A	Painted X Walk1?	No	N/A	Painted X Walk2?	No
	X Walk 1 Direction	To NE		X Walk 2 Direction	To NW
N/A	X Walk 1 Width (in)	N/A	N/A	X Walk 2 Width (in)	N/A
	X Walk 1 Slope (%)	1.3		X Walk 2 Slope (%)	1.8
	X Walk 1 X Slope (%)	1.2		X Walk 2 X Slope (%)	1.7

N/A	Ramp inside XWalk1?	N/A	N/A	Ramp inside XWalk2?	N/A
	Road Slope (%)	1.4	N/A	Clear Space?	N/A
	Road X Slope (%)	3.3	N/A	Clear Space to XWalk (in)	N/A
N/A	Any Obstructions?	N/A	N/A	Storm Grate/Utility Hazard?	N/A
	Obstruction Type			Storm Grate/Utility Type	
		N/A			N/A
		Yes		Surface Condition? (G/P)	Good

Remove & Replace Curb Ramp With Two New Directional Ramps or Equivalent.
