# Access Compliance Report

## Public Rights-of-Way

### (Curb Ramps)

Intersection ID: 18820	Main Street: SEVENTY SEVEN CENTER DR	Cross Street: TYVOLA RD	Location: E
ADA ID: E0100D7C0148	Ramp Type: PerpDiag	Initial Pass/Fail: Fail	Overall Compliance: No
Severity Score: 12.5			
Codes/Mitigation Info/Possible Solution		Field Measurements/Component Compliance

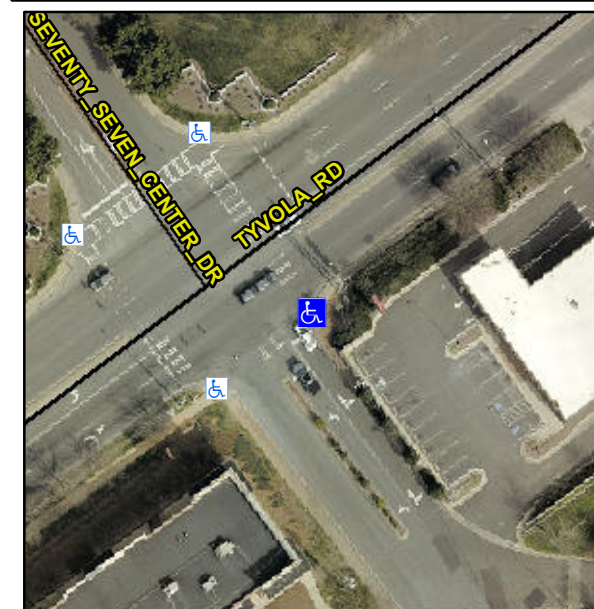
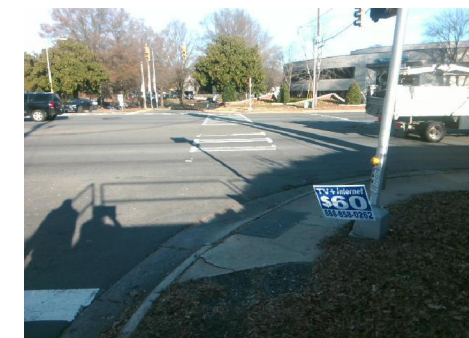
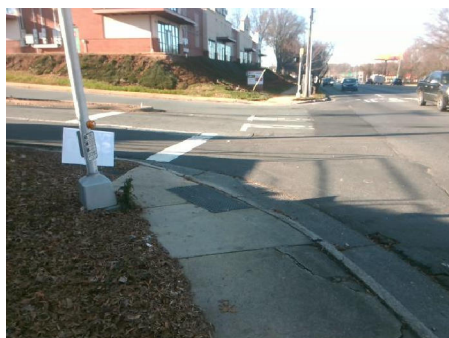
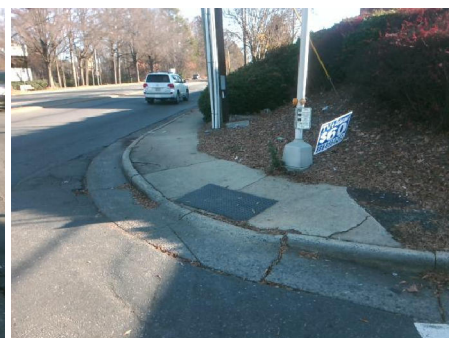
Compliance	Description	Data	Compliance	Description	Data
N/A	Ramp Length (in)	60.0	No	Ramp Slope (%)	8.9
Yes	Ramp Width (in)	48.0	Yes	Ramp XSlope (%)	0.8
N/A	Flare Type LT	N/A	N/A	Flare Type RT	N/A
N/A	Flare Slope LT (%)	N/A	N/A	Flare Slope RT (%)	N/A
N/A	Flare Traversable LT?	N/A	N/A	Flare Traversable RT?	N/A
N/A	Landing Length (in)	N/A	N/A	DWS Provided?	N/A
N/A	Landing Width (in)	N/A	N/A	DWS Contrast?	N/A
N/A	Landing Slope (%)	N/A	N/A	DWS Length (in)	N/A
N/A	Landing X Slope (%)	N/A	N/A	DWS Full Width?	N/A
N/A	Landing Curb? (Y/N)	N/A	N/A	DWS Offset (in)	N/A
N/A	Shared Landing?	N/A			
N/A	Gutter Ponding?	N/A	N/A	Gutter Slope (%)	N/A
N/A	Gutter Lip Ht (in)	N/A	N/A	Gutter X Slope (%)	N/A
N/A	Painted X Walk1?	Yes	N/A	Painted X Walk2?	No
	X Walk 1 Direction	To NW		X Walk 2 Direction	To SW
N/A	X Walk 1 Width (in)	100.0	N/A	X Walk 2 Width (in)	N/A
	X Walk 1 Slope (%)	0.7		X Walk 2 Slope (%)	0.8
	X Walk 1 X Slope (%)	0.7		X Walk 2 X Slope (%)	0.9

N/A	Ramp inside XWalk1?	Yes	N/A	Ramp inside XWalk2?	N/A
	Road Slope (%)	1.3	N/A	Clear Space?	N/A
	Road X Slope (%)	0.8	N/A	Clear Space to XWalk (in)	N/A
N/A	Any Obstructions?	N/A	N/A	Storm Grate/Utility Hazard?	N/A
	Obstruction Type			Storm Grate/Utility Type	
		N/A			N/A
		Yes		Surface Condition? (G/P)	Good

**Remove & Replace Curb Ramp With Two New Directional Ramps or Equivalent.**

**Not Found, R304.2.2**
