Access Compliance Report

Public Rights-of-Way

(Curb Ramps)

Intersection ID: 10541	Main Street: CANTON_PL	Cross Street: POLK_ST	Location:	N
ADA ID: E0103CB110C2	Ramp Type: Perp	Initial Pass/Fail: Fail	Overall Compliance: No	Severity Score: 25
Codes/Mitigation Info/Possible Solution		Field Measurements/Component Compliance

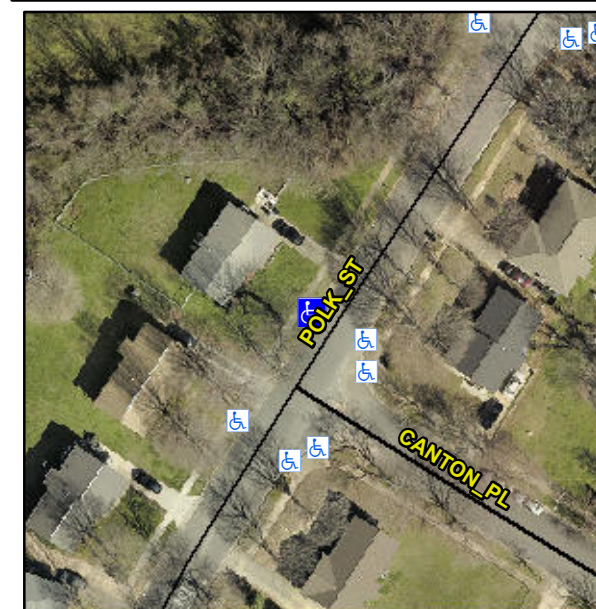
Not Found, R304.2.2

Compliance	Description	Data	Compliance	Description	Data
N/A	Ramp Length (in)	64.0	No	Ramp Slope (%)	12.9
Yes	Ramp Width (in)	49.0	Yes	Ramp XSlope (%)	1.5
N/A	Flare Type LT	N/A	N/A	Flare Type RT	N/A
N/A	Flare Slope LT (%)	N/A	N/A	Flare Slope RT (%)	N/A
N/A	Flare Traversable LT?	N/A	N/A	Flare Traversable RT?	N/A
N/A	Landing Length (in)	N/A	N/A	DWS Provided?	N/A
N/A	Landing Width (in)	N/A	N/A	DWS Contrast?	N/A
N/A	Landing Slope (%)	N/A	N/A	DWS Length (in)	N/A
N/A	Landing X Slope (%)	N/A	N/A	DWS Full Width?	N/A
N/A	Landing Curb? (Y/N)	N/A	N/A	DWS Offset (in)	N/A
N/A	Shared Landing?	N/A			
N/A	Gutter Ponding?	N/A	N/A	Gutter Slope (%)	N/A
N/A	Gutter Lip Ht (in)	1.0	N/A	Gutter X Slope (%)	N/A
N/A	Painted X Walk1?	No	N/A	Painted X Walk2?	N/A
	X Walk 1 Direction	To SE		X Walk 2 Direction	N/A
N/A	X Walk 1 Width (in)	N/A	N/A	X Walk 2 Width (in)	N/A
	X Walk 1 Slope (%)	1.4		X Walk 2 Slope (%)	N/A
	X Walk 1 X Slope (%)	1.8		X Walk 2 X Slope (%)	N/A

N/A	Ramp inside XWalk1?	N/A	N/A	Ramp inside XWalk2?	N/A
	Road Slope (%)	N/A	N/A	Clear Space?	N/A
	Road X Slope (%)	N/A	N/A	Clear Space to XWalk (in)	N/A
N/A	Any Obstructions?	N/A	N/A	Storm Grate/Utility Hazard?	N/A
	Obstruction Type			Storm Grate/Utility Type	
		N/A			N/A
			Yes	Surface Condition? (G/P)	Good

Remove & Replace Entire Ramp.
