Access Compliance Report

Public Rights-of-Way

(Curb Ramps)

Intersection ID: 45967	Main Street: FOREST_MEADOW_DR	Cross Street: IDLEWILD_RD_NORTH	Location: SE
ADA ID: E013887CCC7E	Ramp Type: BlendTrans2	Initial Pass/Fail: Fail	Overall Compliance: No
Severity Score: 10			
Codes/Mitigation Info/Possible Solution		Field Measurements/Component Compliance

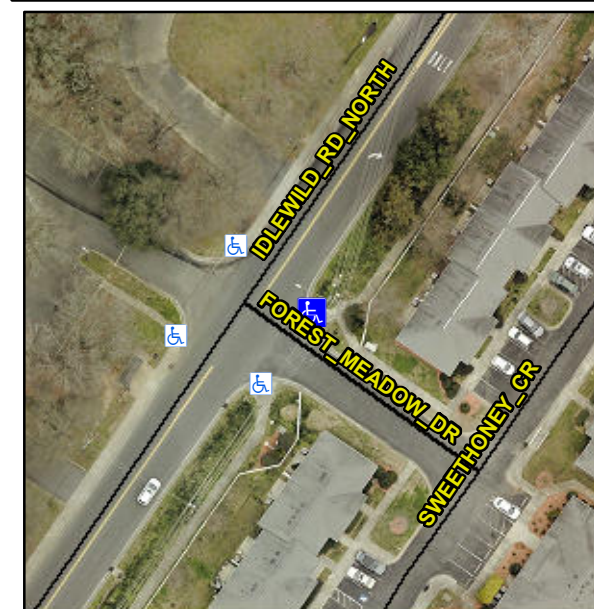
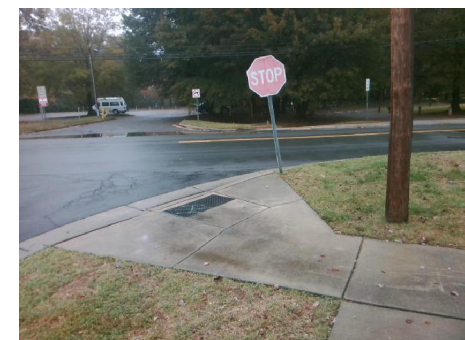
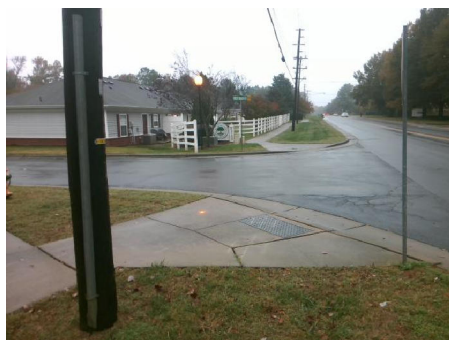
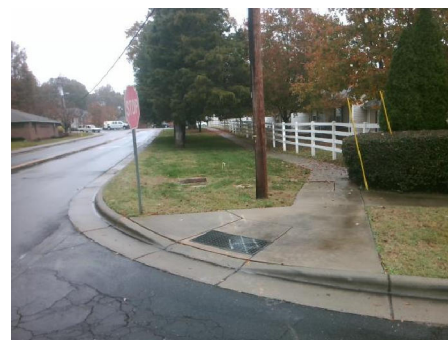
Not Found, R304.5.1, R304.5.3

Compliance	Description	Data	Compliance	Description	Data
N/A	Ramp Length (in)	115.0	Yes	BlendTrans Slope (%)	0.3
No	Ramp Width (in)	41.0	No	BlendTrans XSlope (%)	4.5
N/A	Flare Type LT	N/A	N/A	Flare Type RT	N/A
N/A	Flare Slope LT (%)	N/A	N/A	Flare Slope RT (%)	N/A
N/A	Flare Traversable LT?	N/A	N/A	Flare Traversable RT?	N/A
N/A	Landing Length (in)	N/A	N/A	DWS Provided?	N/A
N/A	Landing Width (in)	N/A	N/A	DWS Contrast?	N/A
N/A	Landing Slope (%)	N/A	N/A	DWS Length (in)	N/A
N/A	Landing X Slope (%)	N/A	N/A	DWS Full Width?	N/A
N/A	Landing Curb? (Y/N)	N/A	N/A	DWS Offset (in)	N/A
N/A	Shared Landing?	N/A			
N/A	Gutter Ponding?	N/A	N/A	Gutter Slope (%)	N/A
N/A	Gutter Lip Ht (in)	1.0	N/A	Gutter X Slope (%)	N/A
N/A	Painted X Walk1?	No	N/A	Painted X Walk2?	No
	X Walk 1 Direction	To NW		X Walk 2 Direction	To SW
	X Walk 1 Width (in)	N/A		X Walk 2 Width (in)	N/A
	X Walk 1 Slope (%)	7.2		X Walk 2 Slope (%)	1.3
	X Walk 1 X Slope (%)	0.9		X Walk 2 X Slope (%)	5.8

N/A	Ramp inside XWalk1?	N/A	N/A	Ramp inside XWalk2?	N/A
	Road Slope (%)	3.9		Clear Space?	N/A
	Road X Slope (%)	7.0	N/A	Clear Space to XWalk (in)	N/A
N/A	Any Obstructions?	N/A	N/A	Storm Grate/Utility Hazard?	N/A
	Obstruction Type			Storm Grate/Utility Type	
		N/A			N/A
			Yes	Surface Condition? (G/P)	Good
			No	Curb Slope (%)	11.6

Possible Solutions:

Remove & Replace Curb Ramp With Two New Directional Ramps or Equivalent.
