Access Compliance Report

Public Rights-of-Way

(Curb Ramps)

Intersection ID: 11684	Main Street: CARLYLE_DR	Cross Street: WILSON_AV	Location: SE
ADA ID: E02D19EF25B3	Ramp Type: BlendTrans1	Initial Pass/Fail: Pass	Overall Compliance: No
		Severity Score: 0.25

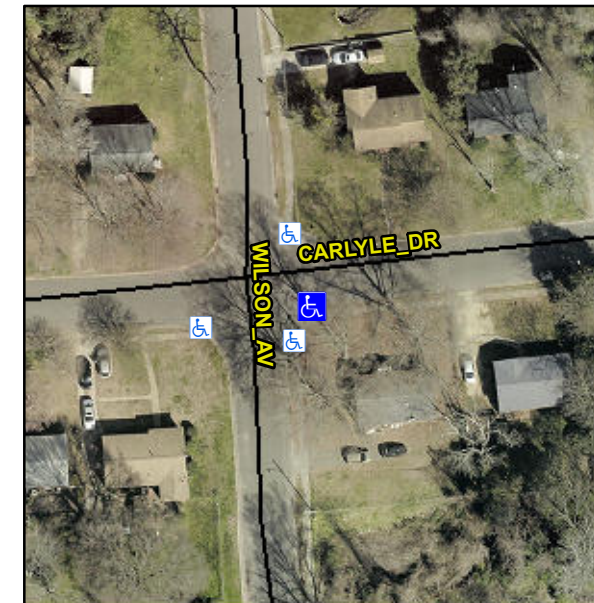
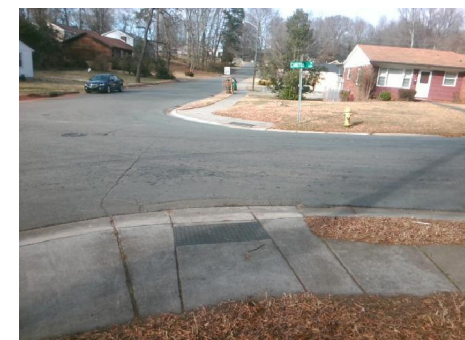
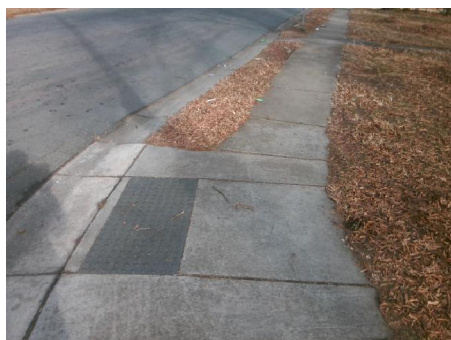
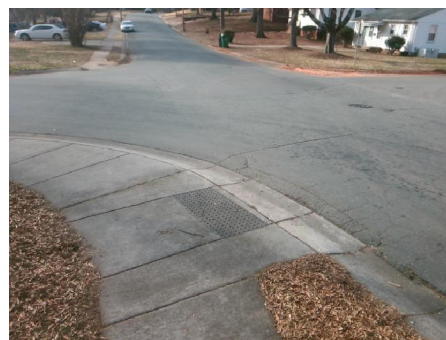
Not Found, R304.2.1, R304.5.3, R305.2

Compliance	Description	Data	Compliance	Description	Data
N/A	Ramp Length (in)	28.0	Yes	BlendTrans Slope (%)	3.5
Yes	Ramp Width (in)	48.0	Yes	BlendTrans XSlope (%)	3.0
N/A	Flare Type LT	Sloped	N/A	Flare Type RT	Sloped
N/A	Flare Slope LT (%)	5.4	Yes	Flare Slope RT (%)	1.0
N/A	Flare Traversable LT?	No	N/A	Flare Traversable RT?	Yes
Yes	Landing Length (in)	49.0	Yes	DWS Provided?	Yes
No	Landing Width (in)	46.5	Yes	DWS Contrast?	Yes
Yes	Landing Slope (%)	0.2	Yes	DWS Length (in)	24.0
No	Landing X Slope (%)	4.0	Yes	DWS Full Width?	Yes
N/A	Landing Curb? (Y/N)	No	No	DWS Offset (in)	4.0
N/A	Shared Landing?	No			
Yes	Gutter Ponding?	No	Yes	Gutter Slope (%)	3.5
Yes	Gutter Lip Ht (in)	0.0	Yes	Gutter X Slope (%)	3.4
N/A	Painted X Walk1?	No	N/A	Painted X Walk2?	N/A
	X Walk 1 Direction	To N		X Walk 2 Direction	N/A
	X Walk 1 Width (in)	N/A		X Walk 2 Width (in)	N/A
	X Walk 1 Slope (%)	4.4		X Walk 2 Slope (%)	N/A
	X Walk 1 X Slope (%)	3.9		X Walk 2 X Slope (%)	N/A

N/A	Ramp inside XWalk1?	N/A	N/A	Ramp inside XWalk2?	N/A
	Road Slope (%)	3.9		Clear Space?	Yes
	Road X Slope (%)	4.4	N/A	Clear Space to XWalk (in)	N/A
Yes	Any Obstructions?	No	Yes	Storm Grate/Utility Hazard?	No
	Obstruction Type			Storm Grate/Utility Type	
		N/A			N/A
			Yes	Surface Condition? (G/P)	Good
			No	Curb Slope (%)	13.1

Remove & Replace Curb Ramp With Two New Directional Ramps or Equivalent.

Total Cost: \$ 3200.00
