# Access Compliance Report

## Public Rights-of-Way

### (Curb Ramps)

Intersection ID: N/A	Main Street: FERNHILL_DR	Cross Street: GREEN_IVY_LN	Location: W
ADA ID: E034A4E53B23	Ramp Type: Perp	Initial Pass/Fail: Fail	Overall Compliance: No
Codes/Mitigation Info/Possible Solution		Field Measurements/Component Compliance	
Severity Score: 8.75

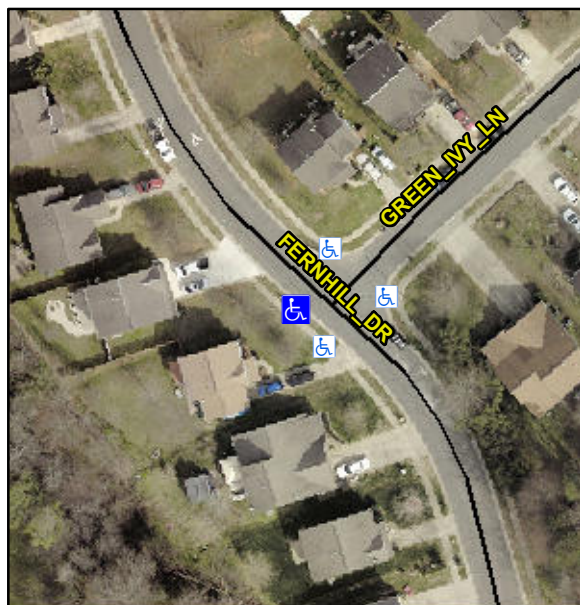
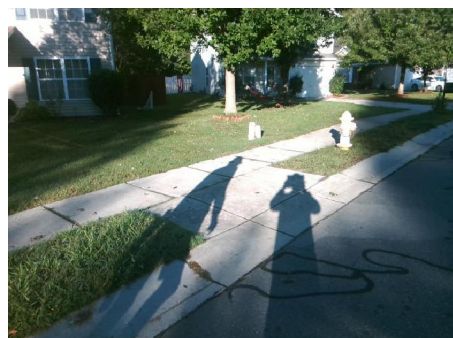
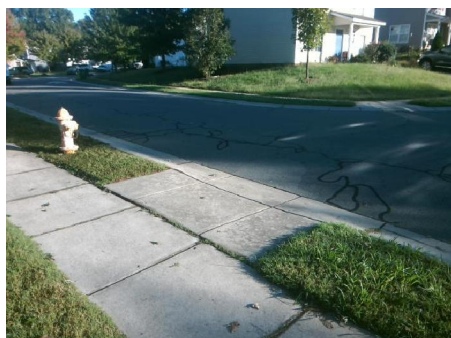
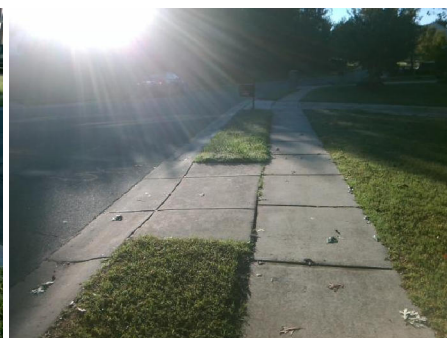
**Not Found, R304.5.1**

Compliance	Description	Data	Compliance	Description	Data
N/A	Ramp Length (in)	44.5	Yes	Ramp Slope (%)	7.0
No	Ramp Width (in)	47.5	Yes	Ramp XSlope (%)	2.0
N/A	Flare Type LT	N/A	N/A	Flare Type RT	N/A
N/A	Flare Slope LT (%)	N/A	N/A	Flare Slope RT (%)	N/A
N/A	Flare Traversable LT?	N/A	N/A	Flare Traversable RT?	N/A
N/A	Landing Length (in)	N/A	N/A	DWS Provided?	N/A
N/A	Landing Width (in)	N/A	N/A	DWS Contrast?	N/A
N/A	Landing Slope (%)	N/A	N/A	DWS Length (in)	N/A
N/A	Landing X Slope (%)	N/A	N/A	DWS Full Width?	N/A
N/A	Landing Curb? (Y/N)	N/A	N/A	DWS Offset (in)	N/A
N/A	Shared Landing?	N/A			
N/A	Gutter Ponding?	N/A	N/A	Gutter Slope (%)	N/A
N/A	Gutter Lip Ht (in)	N/A	N/A	Gutter X Slope (%)	N/A
N/A	Painted X Walk1?	No	N/A	Painted X Walk2?	N/A
	X Walk 1 Direction	To NE		X Walk 2 Direction	N/A
N/A	X Walk 1 Width (in)	N/A	N/A	X Walk 2 Width (in)	N/A
	X Walk 1 Slope (%)	3.4		X Walk 2 Slope (%)	N/A
	X Walk 1 X Slope (%)	1.5		X Walk 2 X Slope (%)	N/A

N/A	Ramp inside XWalk1?	N/A	N/A	Ramp inside XWalk2?	N/A
	Road Slope (%)	N/A	N/A	Clear Space?	N/A
	Road X Slope (%)	N/A	N/A	Clear Space to XWalk (in)	N/A
N/A	Any Obstructions?	N/A	N/A	Storm Grate/Utility Hazard?	N/A
	Obstruction Type			Storm Grate/Utility Type	
		N/A			N/A
		Yes		Surface Condition? (G/P)	Good

**Remove & Replace Entire Ramp.**
