# Access Compliance Report

## Public Rights-of-Way

### (Curb Ramps)

| Intersection ID: N/A | Main Street: ORCHID_BRIDGE_RD | Cross Street: PUMPERNICKEL_RD | Location: SE |

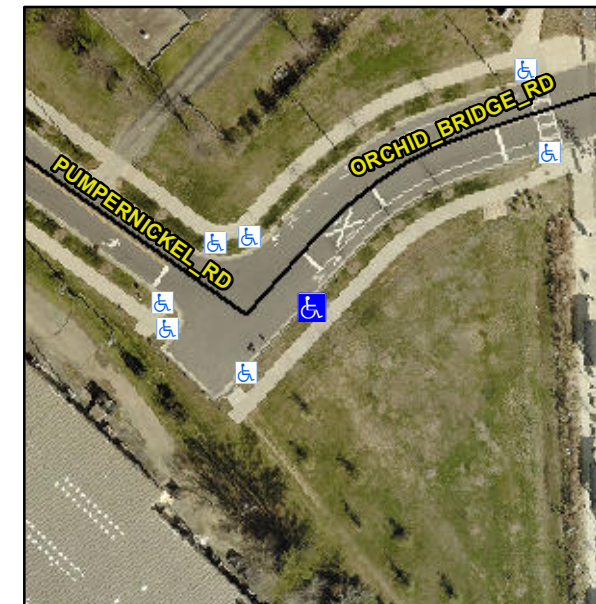
| ADA ID: E042EB31C8B4 | Ramp Type: Perp | Initial Pass/Fail: Fail | Overall Compliance: No |
| Severity Score: 12.5 | | | |

| Compliance | Description | Data | Compliance | Description | Data |
|---|---|---|---|---|---|
| N/A | Ramp Length (in) | 96.0 | No | Ramp Slope (%) | 10.1 |

Possible Solutions:

**Remove & Replace Entire Ramp.**

**R304.2.2**

**\$ 1850.00**

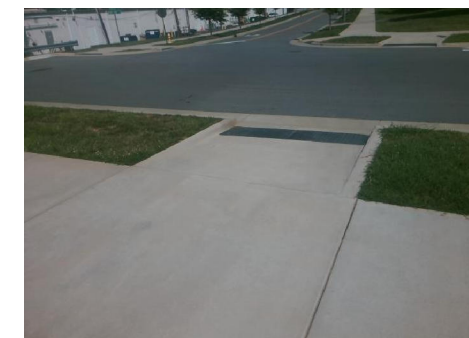
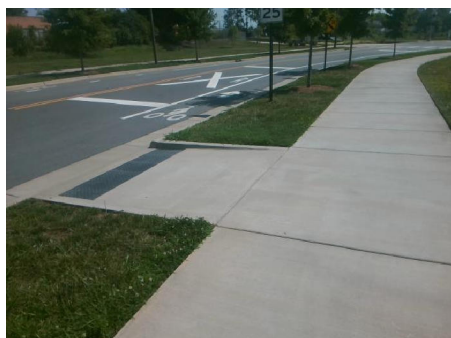
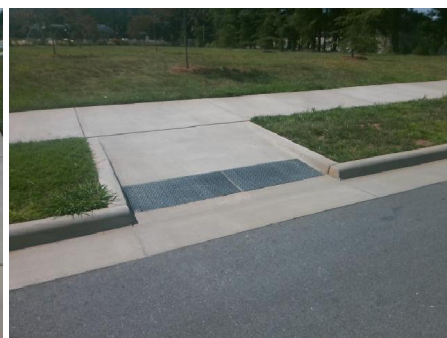
| Compliance | Description | Data | Compliance | Description | Data |
|---|---|---|---|---|---|
| Yes | Ramp Width (in) | 93.0 | Yes | Ramp XSlope (%) | 1.2 |
