Access Compliance Report

Public Rights-of-Way

(Curb Ramps)

Intersection ID: 20933	Main Street: OLD_FARM_RD	Cross Street: PROVIDENCE_RD	Location: W
ADA ID: E0551C7B43B0	Ramp Type: PerpDiag	Initial Pass/Fail: Fail	Overall Compliance: No
Codes/Mitigation Info/Possible Solution		Field Measurements/Component Compliance	
Severity Score: 37.5

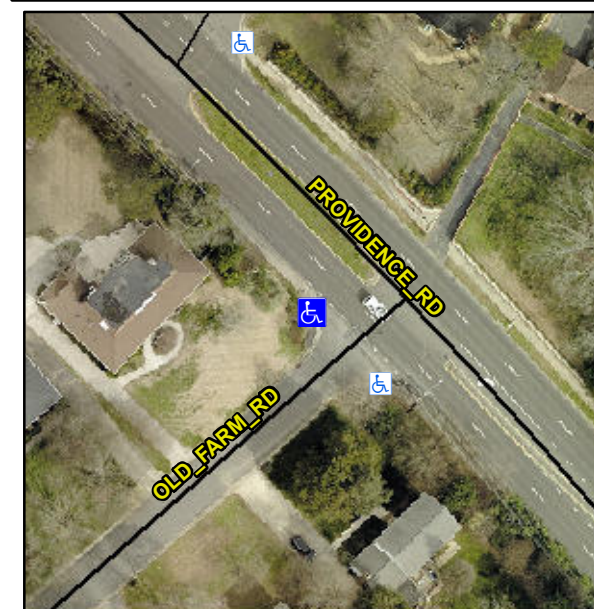
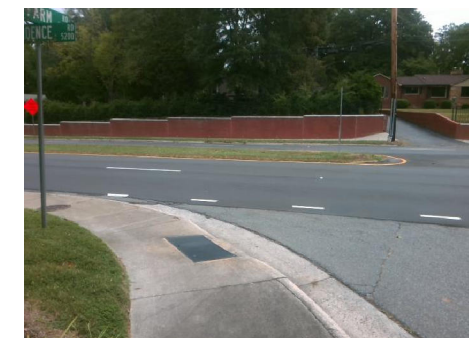
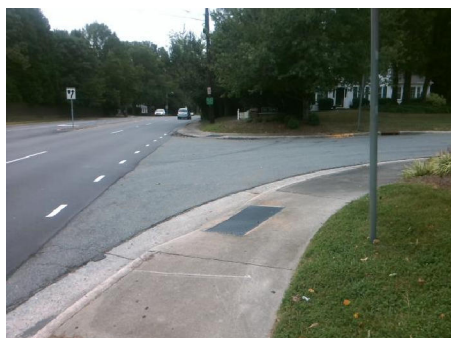
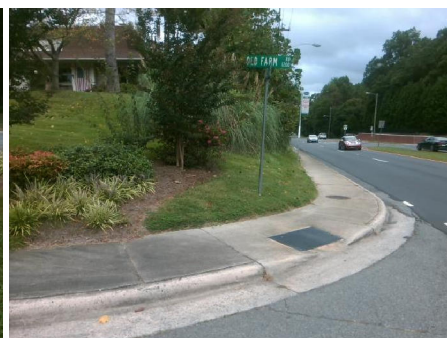
Not Found, R304.2.2, R304.5.3

Compliance	Description	Data	Compliance	Description	Data
N/A	Ramp Length (in)	56.0	No	Ramp Slope (%)	12.0
Yes	Ramp Width (in)	48.0	No	Ramp XSlope (%)	6.9
N/A	Flare Type LT	N/A	N/A	Flare Type RT	N/A
N/A	Flare Slope LT (%)	N/A	N/A	Flare Slope RT (%)	N/A
N/A	Flare Traversable LT?	N/A	N/A	Flare Traversable RT?	N/A
N/A	Landing Length (in)	N/A	N/A	DWS Provided?	N/A
N/A	Landing Width (in)	N/A	N/A	DWS Contrast?	N/A
N/A	Landing Slope (%)	N/A	N/A	DWS Length (in)	N/A
N/A	Landing X Slope (%)	N/A	N/A	DWS Full Width?	N/A
N/A	Landing Curb? (Y/N)	N/A	N/A	DWS Offset (in)	N/A
N/A	Shared Landing?	N/A			
N/A	Gutter Ponding?	N/A	N/A	Gutter Slope (%)	N/A
N/A	Gutter Lip Ht (in)	N/A	N/A	Gutter X Slope (%)	N/A
N/A	Painted X Walk1?	No	N/A	Painted X Walk2?	No
	X Walk 1 Direction	To SE		X Walk 2 Direction	To NE
N/A	X Walk 1 Width (in)	N/A	N/A	X Walk 2 Width (in)	N/A
	X Walk 1 Slope (%)	4.2		X Walk 2 Slope (%)	0.3
	X Walk 1 X Slope (%)	0.9		X Walk 2 X Slope (%)	3.3

N/A	Ramp inside XWalk1?	N/A	N/A	Ramp inside XWalk2?	N/A
	Road Slope (%)	1.9	N/A	Clear Space?	N/A
	Road X Slope (%)	0.0	N/A	Clear Space to XWalk (in)	N/A
N/A	Any Obstructions?	N/A	N/A	Storm Grate/Utility Hazard?	N/A
	Obstruction Type			Storm Grate/Utility Type	
		N/A			N/A
		Yes		Surface Condition? (G/P)	Good

Remove & Replace Curb Ramp With Two New Directional Ramps or Equivalent.
