Access Compliance Report

Public Rights-of-Way

(Curb Ramps)

Intersection ID: 27468	Main Street: BALLANTYNE COMMONS PY	Cross Street: JOHN J DELANEY DR	Location: NW
ADA ID: E0578D6BF0D6	Ramp Type: Perp	Initial Pass/Fail: Fail	Overall Compliance: No
Severity Score: 12.5			
Codes/Mitigation Info/Possible Solution		Field Measurements/Component Compliance

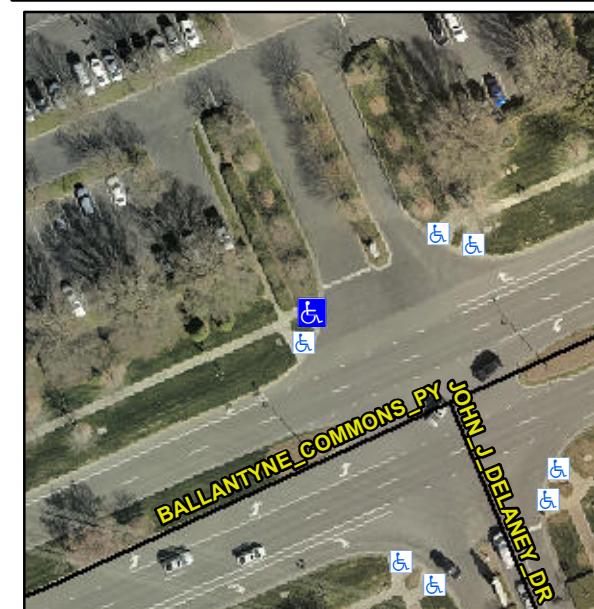
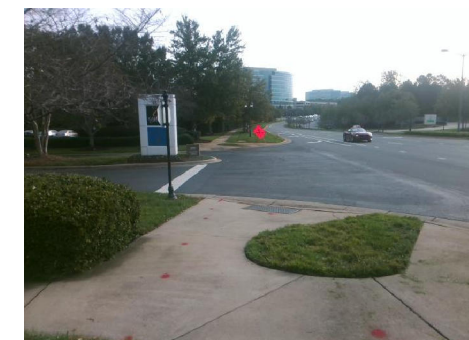
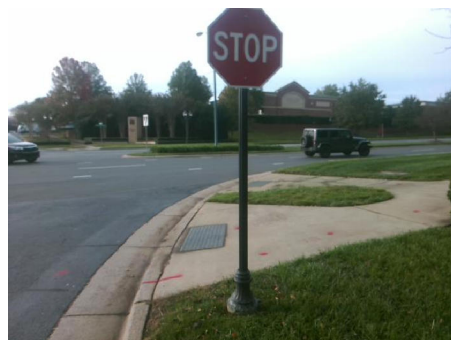
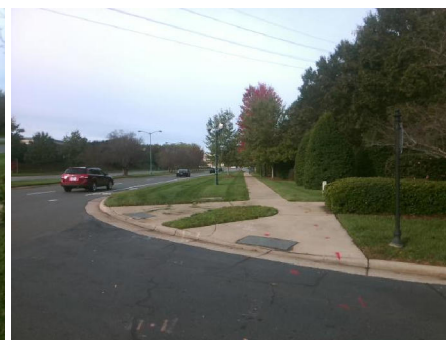
Not Found, R304.2.2

Compliance	Description	Data	Compliance	Description	Data
N/A	Ramp Length (in)	136.0	No	Ramp Slope (%)	9.7
Yes	Ramp Width (in)	48.0	Yes	Ramp XSlope (%)	1.9
N/A	Flare Type LT	N/A	N/A	Flare Type RT	N/A
N/A	Flare Slope LT (%)	N/A	N/A	Flare Slope RT (%)	N/A
N/A	Flare Traversable LT?	N/A	N/A	Flare Traversable RT?	N/A
N/A	Landing Length (in)	N/A	N/A	DWS Provided?	N/A
N/A	Landing Width (in)	N/A	N/A	DWS Contrast?	N/A
N/A	Landing Slope (%)	N/A	N/A	DWS Length (in)	N/A
N/A	Landing X Slope (%)	N/A	N/A	DWS Full Width?	N/A
N/A	Landing Curb? (Y/N)	N/A	N/A	DWS Offset (in)	N/A
N/A	Shared Landing?	N/A			
N/A	Gutter Ponding?	N/A	N/A	Gutter Slope (%)	N/A
N/A	Gutter Lip Ht (in)	N/A	N/A	Gutter X Slope (%)	N/A
N/A	Painted X Walk1?	No	N/A	Painted X Walk2?	N/A
	X Walk 1 Direction	To NE		X Walk 2 Direction	N/A
N/A	X Walk 1 Width (in)	N/A	N/A	X Walk 2 Width (in)	N/A
	X Walk 1 Slope (%)	4.0		X Walk 2 Slope (%)	N/A
	X Walk 1 X Slope (%)	2.7		X Walk 2 X Slope (%)	N/A

Remove & Replace Entire Ramp.

Total Cost: \$ 1850.00
