| Intersection ID: 15386 | Main Street: ALTONDALE_AV | Cross Street: PROVIDENCE_RD | Location: | SE |
| ADA ID: E05EC78E36E0 | Ramp Type: PerpDiag | Initial Pass/Fail: Fail | Overall Compliance: No | Severity Score: 8.75 |

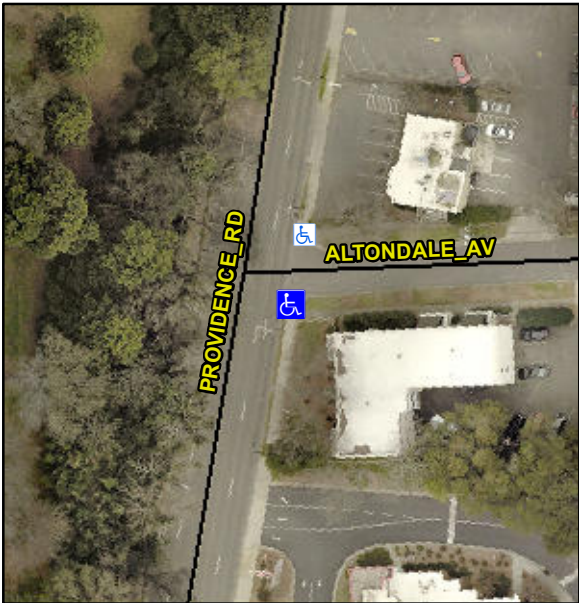
| Codes/Mitigation Info/Possible Solution | | | Field Measurements/Component Compliance | | | | | | | | | | | | | | | |
|---|---|---|---|---|--|---|--|--|---|---|---|---|---|--|--|---|---|---|
| | Remove & Replace Curb Ramp With Two New Directional Ramps or Equivalent. | | N/A | Ramp Length (in) | | | | | | 95.0 | Yes | Ramp Slope (%) | | | | | | 7.0 |
| | | | No | Ramp Width (in) | | | | | | 40.0 | Yes | Ramp XSlope (%) | | | | | | 0.7 |
