# Access Compliance Report

## Public Rights-of-Way

### (Curb Ramps)

Intersection ID: 10519	Main Street: HAMILTON_ST	Cross Street: POLK_ST	Location: E
ADA ID: E0669AFE5B6D	Ramp Type: Perp	Initial Pass/Fail: Fail	Overall Compliance: No
Severity Score: 12.5			
Codes/Mitigation Info/Possible Solution		Field Measurements/Component Compliance

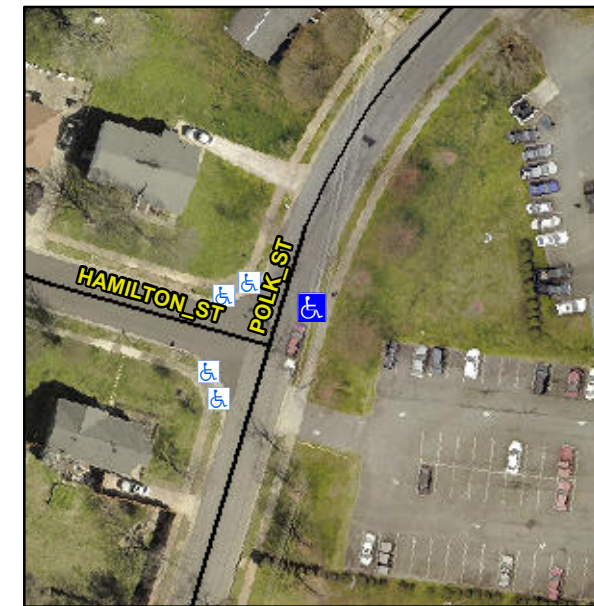
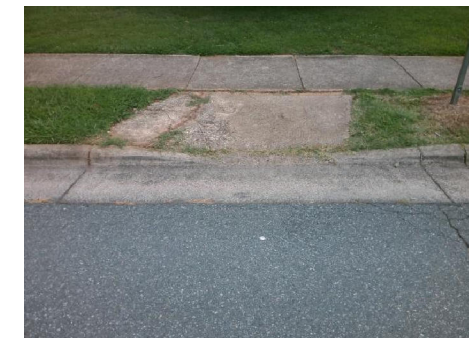
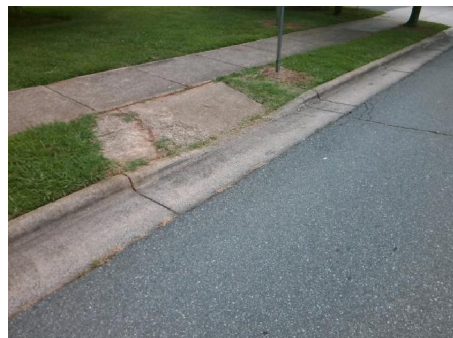
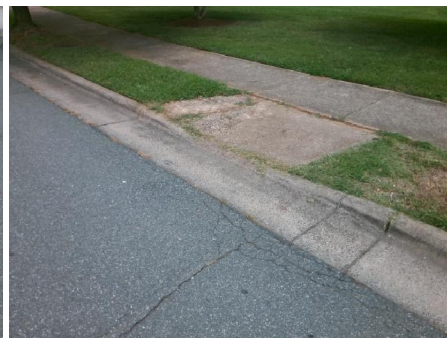
**Not Found, R304.2.2**

Compliance	Description	Data	Compliance	Description	Data
N/A	Ramp Length (in)	53.0	No	Ramp Slope (%)	9.2
Yes	Ramp Width (in)	50.0	Yes	Ramp XSlope (%)	0.7
N/A	Flare Type LT	N/A	N/A	Flare Type RT	N/A
N/A	Flare Slope LT (%)	N/A	N/A	Flare Slope RT (%)	N/A
N/A	Flare Traversable LT?	N/A	N/A	Flare Traversable RT?	N/A
N/A	Landing Length (in)	N/A	N/A	DWS Provided?	N/A
N/A	Landing Width (in)	N/A	N/A	DWS Contrast?	N/A
N/A	Landing Slope (%)	N/A	N/A	DWS Length (in)	N/A
N/A	Landing X Slope (%)	N/A	N/A	DWS Full Width?	N/A
N/A	Landing Curb? (Y/N)	N/A	N/A	DWS Offset (in)	N/A
N/A	Shared Landing?	N/A			
N/A	Gutter Ponding?	N/A	N/A	Gutter Slope (%)	N/A
N/A	Gutter Lip Ht (in)	1.0	N/A	Gutter X Slope (%)	N/A
N/A	Painted X Walk1?	No	N/A	Painted X Walk2?	N/A
	X Walk 1 Direction	To NW		X Walk 2 Direction	N/A
N/A	X Walk 1 Width (in)	N/A	N/A	X Walk 2 Width (in)	N/A
	X Walk 1 Slope (%)	3.1		X Walk 2 Slope (%)	N/A
	X Walk 1 X Slope (%)	2.6		X Walk 2 X Slope (%)	N/A

N/A	Ramp inside XWalk1?	N/A	N/A	Ramp inside XWalk2?	N/A
	Road Slope (%)	N/A	N/A	Clear Space?	N/A
	Road X Slope (%)	N/A	N/A	Clear Space to XWalk (in)	N/A
N/A	Any Obstructions?	N/A	N/A	Storm Grate/Utility Hazard?	N/A
	Obstruction Type			Storm Grate/Utility Type	
		N/A			N/A
			Yes	Surface Condition? (G/P)	Good

**Remove & Replace Entire Ramp.**
