# Access Compliance Report

## Public Rights-of-Way

### (Curb Ramps)

| Intersection ID: 12985 | Main Street: BERRYHILL_RD | Cross Street: PARKER_DR | Location: SE |

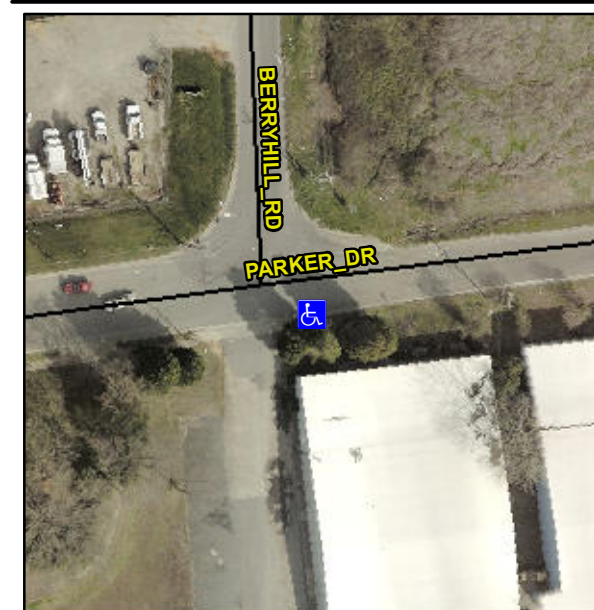
| ADA ID: E06C398C8F2B | Ramp Type: Perp | Initial Pass/Fail: Fail | Overall Compliance: No |

**Not Found, R304.5.1, R304.2.2, R304.5.3**

| Compliance | Description | Data | Compliance | Description | Data |
|---|---|---|---|---|---|
| N/A | Ramp Length (in) | 60.0 | No | Ramp Slope (%) | 11.4 |
| No | Ramp Width (in) | 46.0 | No | Ramp XSlope (%) | 6.1 |

**Remove & Replace Entire Ramp.**
