Access Compliance Report

Public Rights-of-Way

(Curb Ramps)

Intersection ID: 14655	Main Street: CAMERON_AV	Cross Street: E_5TH_ST	Location: NW
ADA ID: E06ED85FD774	Ramp Type: BlendTrans2	Initial Pass/Fail: Fail	Overall Compliance: No
		Severity Score: 1.25

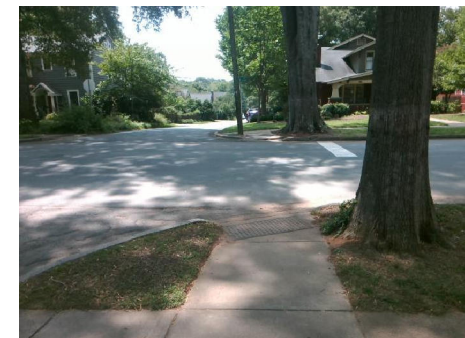
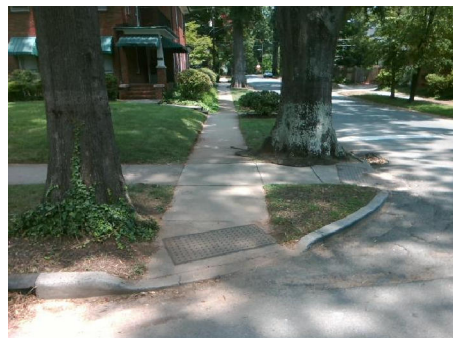
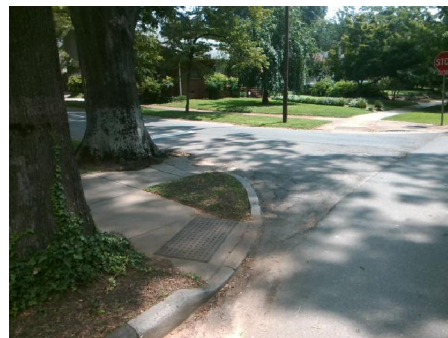
Compliance	Description	Data	Compliance	Description	Data
N/A	Ramp Length (in)	32.0	Yes	BlendTrans Slope (%)	3.0
Yes	Ramp Width (in)	48.0	No	BlendTrans XSlope (%)	2.3
N/A	Flare Type LT	N/A	N/A	Flare Type RT	N/A
N/A	Flare Slope LT (%)	N/A	N/A	Flare Slope RT (%)	N/A
N/A	Flare Traversable LT?	N/A	N/A	Flare Traversable RT?	N/A
N/A	Landing Length (in)	N/A	N/A	DWS Provided?	N/A
N/A	Landing Width (in)	N/A	N/A	DWS Contrast?	N/A
N/A	Landing Slope (%)	N/A	N/A	DWS Length (in)	N/A
N/A	Landing X Slope (%)	N/A	N/A	DWS Full Width?	N/A
N/A	Landing Curb? (Y/N)	N/A	N/A	DWS Offset (in)	N/A
N/A	Shared Landing?	N/A			
N/A	Gutter Ponding?	Yes	N/A	Gutter Slope (%)	N/A
N/A	Gutter Lip Ht (in)	N/A	N/A	Gutter X Slope (%)	N/A
N/A	Painted X Walk1?	No	N/A	Painted X Walk2?	N/A
	X Walk 1 Direction	To SW		X Walk 2 Direction	N/A
	X Walk 1 Width (in)	N/A		X Walk 2 Width (in)	N/A
	X Walk 1 Slope (%)	5.4		X Walk 2 Slope (%)	N/A
	X Walk 1 X Slope (%)	1.1		X Walk 2 X Slope (%)	N/A

N/A	Ramp inside XWalk1?	N/A	N/A	Ramp inside XWalk2?	N/A
	Road Slope (%)	1.1		Clear Space?	N/A
	Road X Slope (%)	5.4	N/A	Clear Space to XWalk (in)	N/A
N/A	Any Obstructions?	N/A	N/A	Storm Grate/Utility Hazard?	N/A
	Obstruction Type			Storm Grate/Utility Type	
		N/A			N/A
			Yes	Surface Condition? (G/P)	Good
			N/A	Curb Slope (%)	2.8

Remove & Replace Curb Ramp With Two New Directional Ramps or Equivalent.

R304.5.3
