Access Compliance Report

Public Rights-of-Way

(Curb Ramps)

Intersection ID: 14442	Main Street: N_SHARON_AMITY_RD	Cross Street: CENTRAL_AV	Location: NE
ADA ID: E074C96AD2D0	Ramp Type: Perp	Initial Pass/Fail: Fail	Overall Compliance: No
Severity Score: 12.5			
Codes/Mitigation Info/Possible Solution		Field Measurements/Component Compliance

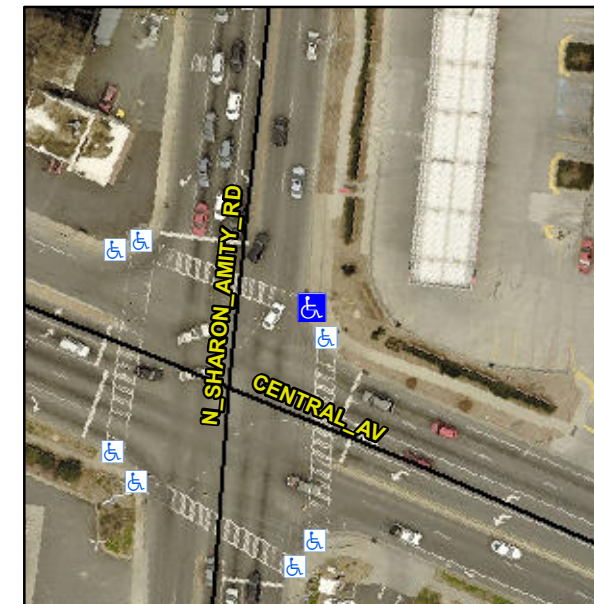
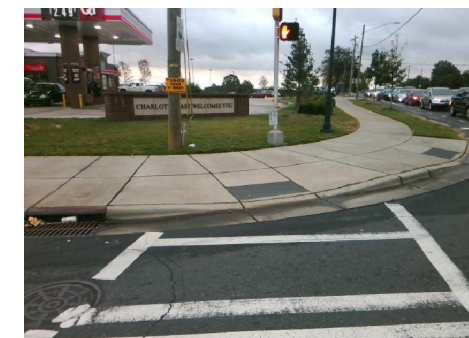
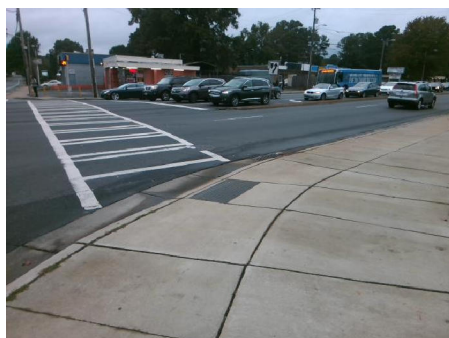
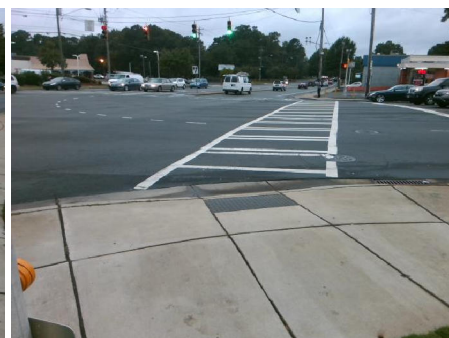
Not Found, R304.2.2

Compliance	Description	Data	Compliance	Description	Data
N/A	Ramp Length (in)	60.5	No	Ramp Slope (%)	8.6
Yes	Ramp Width (in)	48.0	Yes	Ramp XSlope (%)	0.4
N/A	Flare Type LT	N/A	N/A	Flare Type RT	N/A
N/A	Flare Slope LT (%)	N/A	N/A	Flare Slope RT (%)	N/A
N/A	Flare Traversable LT?	N/A	N/A	Flare Traversable RT?	N/A
N/A	Landing Length (in)	N/A	N/A	DWS Provided?	N/A
N/A	Landing Width (in)	N/A	N/A	DWS Contrast?	N/A
N/A	Landing Slope (%)	N/A	N/A	DWS Length (in)	N/A
N/A	Landing X Slope (%)	N/A	N/A	DWS Full Width?	N/A
N/A	Landing Curb? (Y/N)	N/A	N/A	DWS Offset (in)	N/A
N/A	Shared Landing?	N/A			
N/A	Gutter Ponding?	N/A	N/A	Gutter Slope (%)	N/A
N/A	Gutter Lip Ht (in)	N/A	N/A	Gutter X Slope (%)	N/A
N/A	Painted X Walk1?	Yes	N/A	Painted X Walk2?	N/A
	X Walk 1 Direction	To NW		X Walk 2 Direction	N/A
N/A	X Walk 1 Width (in)	112.0	N/A	X Walk 2 Width (in)	N/A
	X Walk 1 Slope (%)	2.6		X Walk 2 Slope (%)	N/A
	X Walk 1 X Slope (%)	0.9		X Walk 2 X Slope (%)	N/A

N/A	Ramp inside XWalk1?	Yes	N/A	Ramp inside XWalk2?	N/A
	Road Slope (%)	N/A	N/A	Clear Space?	N/A
	Road X Slope (%)	N/A	N/A	Clear Space to XWalk (in)	N/A
N/A	Any Obstructions?	N/A	N/A	Storm Grate/Utility Hazard?	N/A
	Obstruction Type			Storm Grate/Utility Type	
		N/A			N/A
		Yes		Surface Condition? (G/P)	Good

Remove & Replace Entire Ramp.
