Access Compliance Report

Public Rights-of-Way

(Curb Ramps)

| Intersection ID: 48460 | Main Street: TARPWAY_RD | Cross Street: PANGLEMONT_DR | Location: SE |

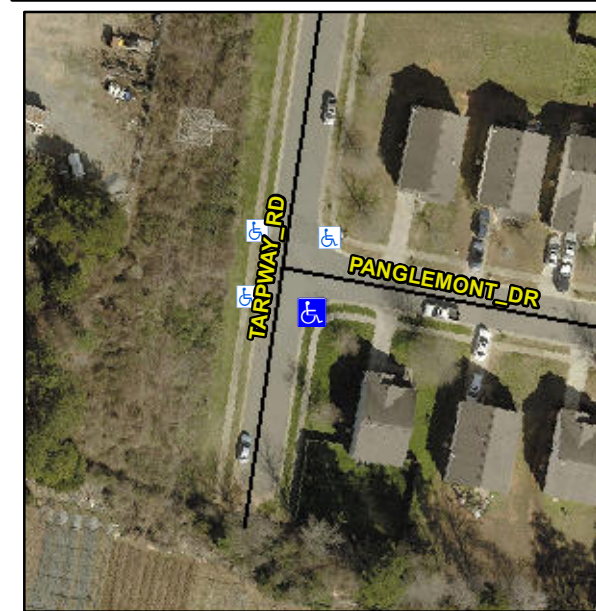
Not Found, R304.5.1, R304.2.2

| Compliance | Description | Data | Compliance | Description | Data |
|---|---|---|---|---|---|
| N/A | Ramp Length (in) | 47.5 | No | Ramp Slope (%) | 8.5 |
| No | Ramp Width (in) | 46.0 | Yes | Ramp XSlope (%) | 0.0 |

Remove & Replace Curb Ramp With Two New Directional Ramps or Equivalent.
