Access Compliance Report

Public Rights-of-Way

(Curb Ramps)

Intersection ID: 50617	Main Street: GOLDEN_WOOD_LN	Cross Street: PADDLE_OAK_RD	Location: SW
ADA ID: E07FB32CB494	Ramp Type: Perp	Initial Pass/Fail: Fail	Overall Compliance: No
Severity Score: 33.75			
Codes/Mitigation Info/Possible Solution		Field Measurements/Component Compliance

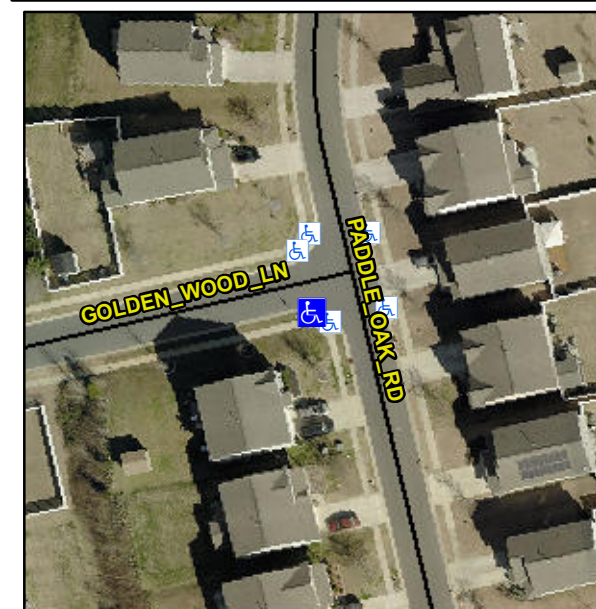
Compliance	Description	Data	Compliance	Description	Data
N/A	Ramp Length (in)	48.0	No	Ramp Slope (%)	9.2
No	Ramp Width (in)	47.5	No	Ramp XSlope (%)	5.6
N/A	Flare Type LT	N/A	N/A	Flare Type RT	N/A
N/A	Flare Slope LT (%)	N/A	N/A	Flare Slope RT (%)	N/A
N/A	Flare Traversable LT?	N/A	N/A	Flare Traversable RT?	N/A
N/A	Landing Length (in)	N/A	N/A	DWS Provided?	N/A
N/A	Landing Width (in)	N/A	N/A	DWS Contrast?	N/A
N/A	Landing Slope (%)	N/A	N/A	DWS Length (in)	N/A
N/A	Landing X Slope (%)	N/A	N/A	DWS Full Width?	N/A
N/A	Landing Curb? (Y/N)	N/A	N/A	DWS Offset (in)	N/A
N/A	Shared Landing?	N/A			
N/A	Gutter Ponding?	N/A	N/A	Gutter Slope (%)	N/A
N/A	Gutter Lip Ht (in)	N/A	N/A	Gutter X Slope (%)	N/A
N/A	Painted X Walk1?	No	N/A	Painted X Walk2?	N/A
	X Walk 1 Direction	To N		X Walk 2 Direction	N/A
N/A	X Walk 1 Width (in)	N/A	N/A	X Walk 2 Width (in)	N/A
	X Walk 1 Slope (%)	0.9		X Walk 2 Slope (%)	N/A
	X Walk 1 X Slope (%)	3.3		X Walk 2 X Slope (%)	N/A

N/A	Ramp inside XWalk1?	N/A	N/A	Ramp inside XWalk2?	N/A
	Road Slope (%)	N/A	N/A	Clear Space?	N/A
	Road X Slope (%)	N/A	N/A	Clear Space to XWalk (in)	N/A
N/A	Any Obstructions?	N/A	N/A	Storm Grate/Utility Hazard?	N/A
	Obstruction Type			Storm Grate/Utility Type	
		N/A			N/A
			Yes	Surface Condition? (G/P)	Good

Possible Solutions:

Remove & Replace Entire Ramp.

R304.5.1, R304.2.2, R304.5.3
