Access Compliance Report

Public Rights-of-Way

(Curb Ramps)

Intersection ID: 10022679	Main Street: CARNEGIE_BV	Cross Street: N/A	Location:	N
ADA ID: E0AD594CF2B0	Ramp Type: Perp	Initial Pass/Fail: Pass	Overall Compliance: No	Severity Score: 15

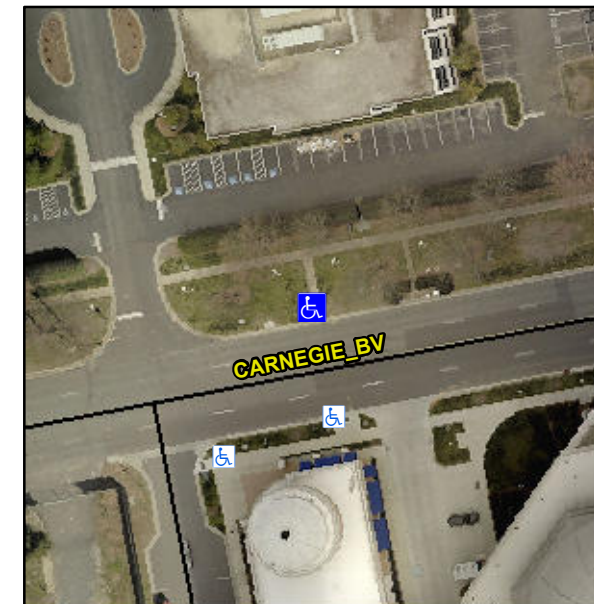
**Not Found, R304.2.2-Perp, R304.3.2-
Para, R305, R304.5.4**

Compliance	Description	Data	Compliance	Description	Data
N/A	Ramp Length (in)	129.0	Yes	Ramp Slope (%)	6.4
Yes	Ramp Width (in)	48.0	Yes	Ramp XSlope (%)	1.3
N/A	Flare Type LT	None	N/A	Flare Type RT	N/A
N/A	Flare Slope LT (%)	N/A	N/A	Flare Slope RT (%)	N/A
N/A	Flare Traversable LT?	N/A	N/A	Flare Traversable RT?	N/A
Yes	Landing Length (in)	62.0	No	DWS Provided?	No
Yes	Landing Width (in)	60.0	N/A	DWS Contrast?	No
No	Landing Slope (%)	2.2	N/A	DWS Length (in)	N/A
Yes	Landing X Slope (%)	0.3	N/A	DWS Full Width?	No
N/A	Landing Curb? (Y/N)	No	N/A	DWS Offset (in)	N/A
N/A	Shared Landing?	No			
Yes	Gutter Ponding?	No	No	Gutter Slope (%)	5.6
Yes	Gutter Lip Ht (in)	0.0	Yes	Gutter X Slope (%)	0.7
N/A	Painted X Walk1?	No	N/A	Painted X Walk2?	N/A
	X Walk 1 Direction	To S		X Walk 2 Direction	N/A
N/A	X Walk 1 Width (in)	N/A	N/A	X Walk 2 Width (in)	N/A
	X Walk 1 Slope (%)	2.6		X Walk 2 Slope (%)	N/A
	X Walk 1 X Slope (%)	0.0		X Walk 2 X Slope (%)	N/A

N/A	Ramp inside XWalk1?	N/A	N/A	Ramp inside XWalk2?	N/A
	Road Slope (%)	N/A	N/A	Clear Space?	Yes
	Road X Slope (%)	N/A	N/A	Clear Space to XWalk (in)	N/A
Yes	Any Obstructions?	No	Yes	Storm Grate/Utility Hazard?	No
	Obstruction Type			Storm Grate/Utility Type	
			N/A		N/A
			Yes	Surface Condition? (G/P)	Good

**Remove & Replace Entire Ramp.
Remove & Replace Gutter.**
