# Access Compliance Report

## Public Rights-of-Way

### (Curb Ramps)

Intersection ID: 18095	Main Street: DRIFTER_DR	Cross Street: IDLEWILD_RD	Location: SW
ADA ID: E0B637899611	Ramp Type: Directional1	Initial Pass/Fail: Pass	Overall Compliance: No
		Severity Score: 5

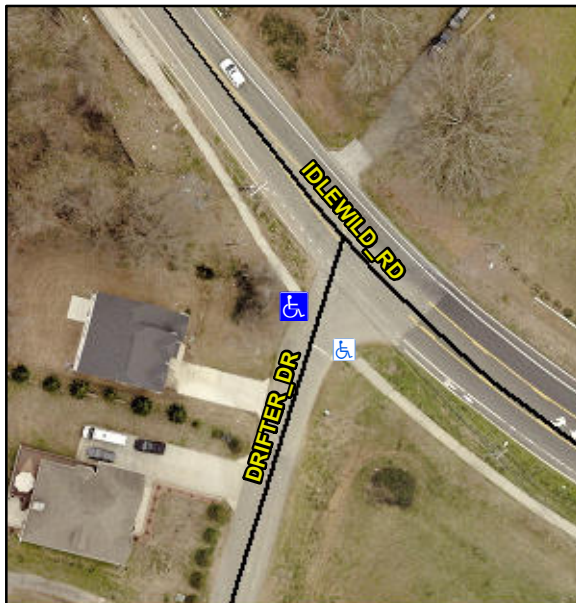
**LNDG SLOPE NEGATIVE**

Compliance	Description	Data	Compliance	Description	Data
N/A	Ramp Length (in)	60.0	Yes	Grade Break?	Yes
Yes	Ramp Width (in)	67.0	Yes	Grade Break Slope (%)	0.5
Yes	Ramp Slope (%)	0.1	Yes	Grade Break XSlope (%)	1.9
Yes	Ramp XSlope (%)	1.2			
N/A	Flare Type LT	N/A	N/A	Flare Type RT	N/A
N/A	Flare Slope LT (%)	N/A	N/A	Flare Slope RT (%)	N/A
N/A	Flare Traversable LT?	N/A	N/A	Flare Traversable RT?	N/A
Yes	Landing Length (in)	78.5	Yes	DWS Provided?	Yes
Yes	Landing Width (in)	67.0	Yes	DWS Contrast?	Yes
No	Landing Slope (%)	6.5	Yes	DWS Length (in)	24.0
No	Landing X Slope (%)	2.1	Yes	DWS Full Width?	Yes
N/A	Landing Curb? (Y/N)	No	Yes	DWS Offset LT (in)	26.0
N/A	Shared Landing?	No	Yes	DWS Offset RT (in)	0.0
Yes	Gutter Ponding?	No	No	Gutter Slope (%)	5.1
Yes	Gutter Lip Ht (in)	0.0	Yes	Gutter X Slope (%)	1.8
N/A	Painted X Walk1?	No		Road Slope (%)	6.4
	X Walk 1 Direction	To SE		Road X Slope (%)	1.0
	X Walk 1 Width (in)	N/A		Clear Space?	Yes

X Walk 1 Slope (%)	6.4	N/A	Clear Space to XWalk (in)	N/A
	X Walk 1 X Slope (%)	1.0	Yes	Storm Grate/Utility Hazard?	No
N/A	Ramp inside XWalk1?	N/A		Storm Grate/Utility Type	
Yes	Any Obstructions?	No			N/A
	Obstruction Type		Yes	Surface Condition? (G/P)	Good
			N/A	Curb Slope (%)	3.2

Possible Solutions:

**Remove & Replace Landing.**  
**Remove & Replace Gutter.**

**R304.2.2-Perp, R304.3.2-Para,**  
**R304.5.3, R304.5.4**
