Access Compliance Report

Public Rights-of-Way

(Curb Ramps)

Intersection ID: 52771	Main Street: DESIGNER_DR	Cross Street: OUTLETS_BV	Location: NE
ADA ID: E0B922485730	Ramp Type: PerpDiag	Initial Pass/Fail: Fail	Overall Compliance: No
		Severity Score: 8.75

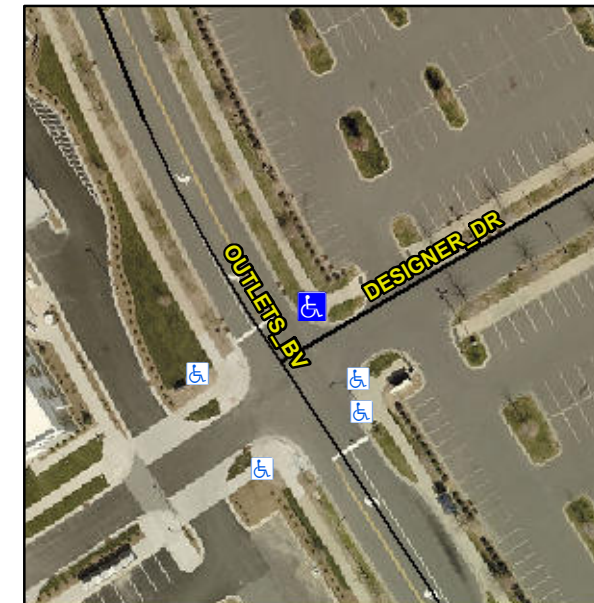
Not Found, R304.5.1

Compliance	Description	Data	Compliance	Description	Data
N/A	Ramp Length (in)	90.5	Yes	Ramp Slope (%)	7.6
No	Ramp Width (in)	45.0	Yes	Ramp XSlope (%)	1.3
N/A	Flare Type LT	N/A	N/A	Flare Type RT	N/A
N/A	Flare Slope LT (%)	N/A	N/A	Flare Slope RT (%)	N/A
N/A	Flare Traversable LT?	N/A	N/A	Flare Traversable RT?	N/A
N/A	Landing Length (in)	N/A	N/A	DWS Provided?	N/A
N/A	Landing Width (in)	N/A	N/A	DWS Contrast?	N/A
N/A	Landing Slope (%)	N/A	N/A	DWS Length (in)	N/A
N/A	Landing X Slope (%)	N/A	N/A	DWS Full Width?	N/A
N/A	Landing Curb? (Y/N)	N/A	N/A	DWS Offset (in)	N/A
N/A	Shared Landing?	N/A			
N/A	Gutter Ponding?	N/A	N/A	Gutter Slope (%)	N/A
N/A	Gutter Lip Ht (in)	N/A	N/A	Gutter X Slope (%)	N/A
N/A	Painted X Walk1?	No	N/A	Painted X Walk2?	No
	X Walk 1 Direction	To W		X Walk 2 Direction	To S
N/A	X Walk 1 Width (in)	N/A	N/A	X Walk 2 Width (in)	N/A
	X Walk 1 Slope (%)	2.3		X Walk 2 Slope (%)	1.6
	X Walk 1 X Slope (%)	1.9		X Walk 2 X Slope (%)	1.2

Remove & Replace Curb Ramp With Two New Directional Ramps or Equivalent.
