Access Compliance Report

Public Rights-of-Way

(Curb Ramps)

Intersection ID: 52988	Main Street: LANDING_PLACE_LN	Cross Street: GREYTHORNE_DR	Location: NE
ADA ID: E0BC14EAC372	Ramp Type: BlendTrans1	Initial Pass/Fail: Fail	Overall Compliance: No
Severity Score: 12.5			
Codes/Mitigation Info/Possible Solution		Field Measurements/Component Compliance

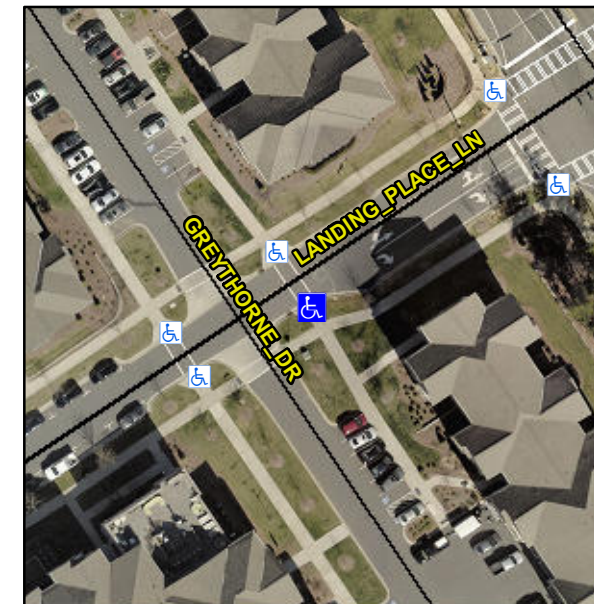
PROW/ADA:

Not Found, R304.5.3

Compliance	Description	Data	Compliance	Description	Data
N/A	Ramp Length (in)	82.0	Yes	BlendTrans Slope (%)	3.1
Yes	Ramp Width (in)	83.0	No	BlendTrans XSlope (%)	6.1
N/A	Flare Type LT	N/A	N/A	Flare Type RT	N/A
N/A	Flare Slope LT (%)	N/A	N/A	Flare Slope RT (%)	N/A
N/A	Flare Traversable LT?	N/A	N/A	Flare Traversable RT?	N/A
N/A	Landing Length (in)	N/A	N/A	DWS Provided?	N/A
N/A	Landing Width (in)	N/A	N/A	DWS Contrast?	N/A
N/A	Landing Slope (%)	N/A	N/A	DWS Length (in)	N/A
N/A	Landing X Slope (%)	N/A	N/A	DWS Full Width?	N/A
N/A	Landing Curb? (Y/N)	N/A	N/A	DWS Offset (in)	N/A
N/A	Shared Landing?	N/A			
N/A	Gutter Ponding?	N/A	N/A	Gutter Slope (%)	N/A
N/A	Gutter Lip Ht (in)	N/A	N/A	Gutter X Slope (%)	N/A
N/A	Painted X Walk1?	Yes	N/A	Painted X Walk2?	N/A
	X Walk 1 Direction	To NW		X Walk 2 Direction	N/A
	X Walk 1 Width (in)	82.0		X Walk 2 Width (in)	N/A
	X Walk 1 Slope (%)	1.7		X Walk 2 Slope (%)	N/A
	X Walk 1 X Slope (%)	5.9		X Walk 2 X Slope (%)	N/A

N/A	Ramp inside XWalk1?	Yes	N/A	Ramp inside XWalk2?	N/A
	Road Slope (%)	5.9		Clear Space?	N/A
	Road X Slope (%)	1.7	N/A	Clear Space to XWalk (in)	N/A
N/A	Any Obstructions?	N/A	N/A	Storm Grate/Utility Hazard?	N/A
	Obstruction Type			Storm Grate/Utility Type	
		N/A			N/A
			Yes	Surface Condition? (G/P)	Good
			No	Curb Slope (%)	6.0

Possible Solutions:

Remove & Replace Curb Ramp With Two New Directional Ramps or Equivalent.
