Access Compliance Report

Public Rights-of-Way

(Curb Ramps)

Intersection ID: 16629	Main Street: SCALEYBARK_RD	Cross Street: HAVERHILL_DR	Location: NE
ADA ID: E0C577A20EAC	Ramp Type: Combination2	Initial Pass/Fail: Fail	Overall Compliance: No
Severity Score: 8.75			
Codes/Mitigation Info/Possible Solution		Field Measurements/Component Compliance

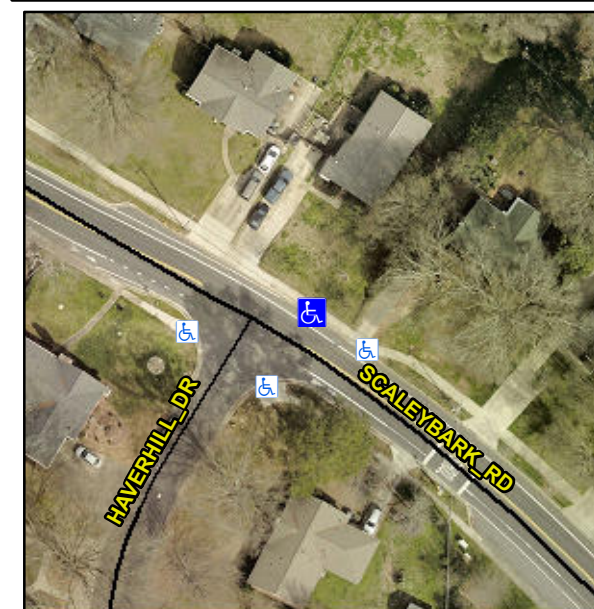
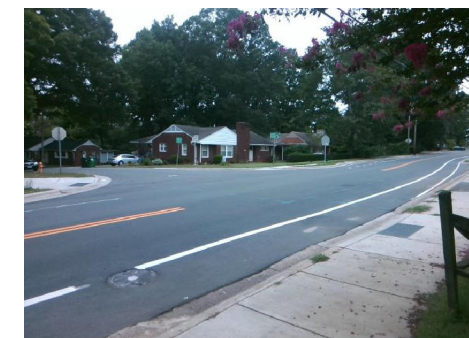
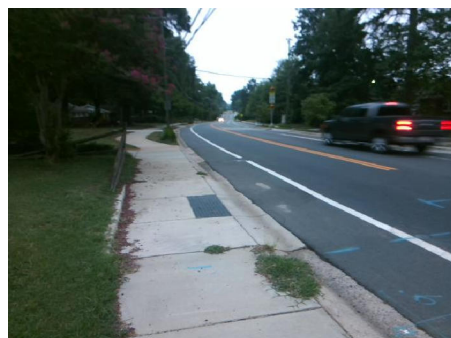
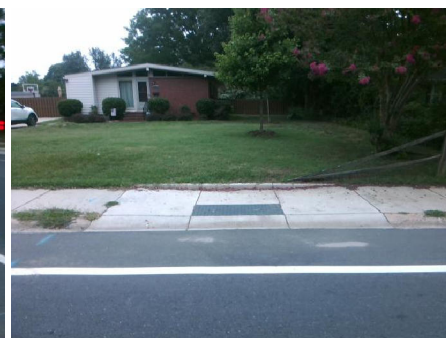
Not Found, R304.5.1

Compliance	Description	Data	Compliance	Description	Data
N/A	Ramp Length LT (in)	58.0	N/A	Ramp Length RT (in)	N/A
No	Ramp Width LT (in)	46.5	N/A	Ramp Width RT (in)	N/A
Yes	Ramp Slope LT (%)	5.9	N/A	Ramp Slope RT (%)	N/A
Yes	Ramp XSlope LT (%)	1.5	N/A	Ramp XSlope RT (%)	N/A
N/A	Ramp Length (in)	24.0	Yes	Ramp Slope (%)	3.4
Yes	Ramp Width (in)	60.0	Yes	Ramp XSlope (%)	0.5
N/A	Flare Type LT	N/A	N/A	Flare Type RT	N/A
N/A	Flare Slope LT (%)	N/A	N/A	Flare Slope RT (%)	N/A
N/A	Flare Traversable LT?	N/A	N/A	Flare Traversable RT?	N/A
N/A	Landing Length (in)	N/A	N/A	DWS Provided?	N/A
N/A	Landing Width (in)	N/A	N/A	DWS Contrast?	N/A
N/A	Landing Slope (%)	N/A	N/A	DWS Length (in)	N/A
N/A	Landing X Slope (%)	N/A	N/A	DWS Full Width?	N/A
N/A	Landing Curb? (Y/N)	N/A	N/A	DWS Offset (in)	N/A
N/A	Shared Landing?	N/A			
N/A	Gutter Ponding?	N/A	N/A	Gutter Slope (%)	N/A
N/A	Gutter Lip Ht (in)	N/A	N/A	Gutter X Slope (%)	N/A
N/A	Painted X Walk1?	No	N/A	Painted X Walk2?	N/A

X Walk 1 Direction	To SW		X Walk 2 Direction	N/A
	X Walk 1 Width (in)	N/A		X Walk 2 Width (in)	N/A
	X Walk 1 Slope (%)	1.8		X Walk 2 Slope (%)	N/A
	X Walk 1 X Slope (%)	1.0		X Walk 2 X Slope (%)	N/A
N/A	Ramp inside XWalk1?	N/A	N/A	Ramp inside XWalk2?	N/A
	Road Slope (%)	N/A		Clear Space?	N/A
	Road X Slope (%)	N/A	N/A	Clear Space to XWalk (in)	N/A
			N/A	Any Obstruction?	N/A
				Obstruction Type	N/A
			N/A	Storm Grate/Utility Hazard?	N/A
				Storm Grate/Utility Type	N/A
			Yes	Surface Condition? (G/P)	Good
				Curb Slope (%)	23.5

Remove & Replace Entire Ramp.
