# Access Compliance Report

## Public Rights-of-Way

### (Curb Ramps)

Intersection ID: 18050	Main Street: S_TRYON_ST	Cross Street: SOUTHAMPTON_RD	Location: NE
ADA ID: E0C7A4DA8D5C	Ramp Type: Directional1	Initial Pass/Fail: Fail	Overall Compliance: No
Severity Score: 1.25			
Codes/Mitigation Info/Possible Solution		Field Measurements/Component Compliance

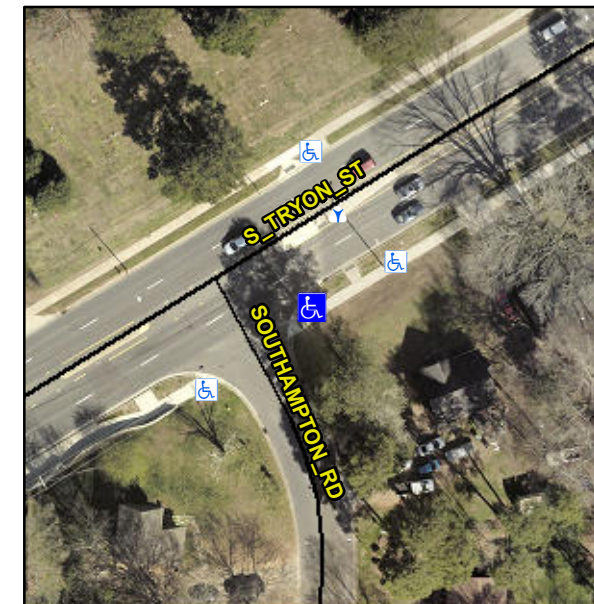
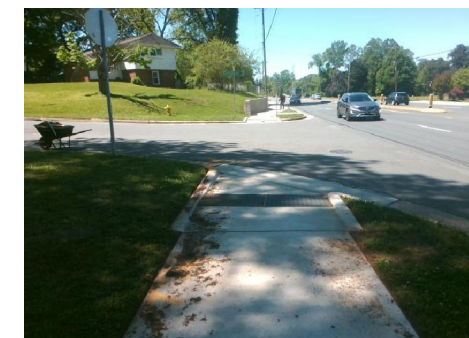
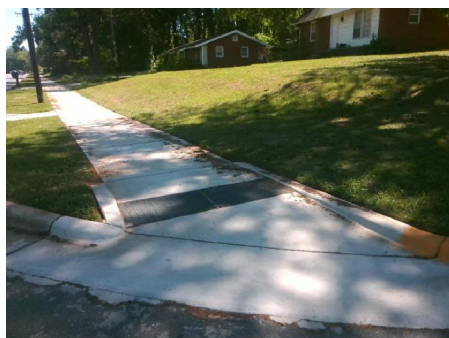
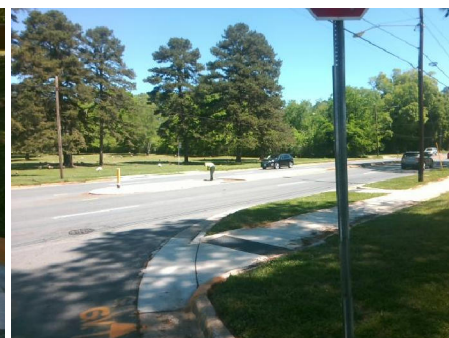
**R304.5.3**

Compliance	Description	Data	Compliance	Description	Data
N/A	Ramp Length (in)	60.0	N/A	Grade Break?	N/A
Yes	Ramp Width (in)	72.0	N/A	Grade Break Slope (%)	0.0
Yes	Ramp Slope (%)	5.1	N/A	Grade Break XSlope (%)	0.0
No	Ramp XSlope (%)	4.0			
N/A	Flare Type LT	N/A	N/A	Flare Type RT	N/A
N/A	Flare Slope LT (%)	N/A	N/A	Flare Slope RT (%)	0.0
N/A	Flare Traversable LT?	N/A	N/A	Flare Traversable RT?	N/A
N/A	Landing Length (in)	0.0	N/A	DWS Provided?	N/A
N/A	Landing Width (in)	0.0	N/A	DWS Contrast?	N/A
N/A	Landing Slope (%)	0.0	N/A	DWS Length (in)	N/A
N/A	Landing X Slope (%)	0.0	N/A	DWS Full Width?	N/A
N/A	Landing Curb? (Y/N)	N/A	N/A	DWS Offset LT (in)	N/A
N/A	Shared Landing?	N/A	N/A	DWS Offset RT (in)	N/A
N/A	Gutter Ponding?	0.0	N/A	Gutter Slope (%)	N/A
N/A	Gutter Lip Ht (in)	0.0	N/A	Gutter X Slope (%)	N/A
N/A	Painted X Walk1?	No		Road Slope (%)	2.8
	X Walk 1 Direction	To SW		Road X Slope (%)	5.2
	X Walk 1 Width (in)	N/A		Clear Space?	N/A

X Walk 1 Slope (%)	2.8	N/A	Clear Space to XWalk (in)	N/A
	X Walk 1 X Slope (%)	5.2	N/A	Storm Grate/Utility Hazard?	N/A
N/A	Ramp inside XWalk1?	N/A		Storm Grate/Utility Type	
N/A	Any Obstructions?	N/A			N/A
	Obstruction Type		Yes	Surface Condition? (G/P)	Good
			N/A	Curb Slope (%)	0.3

**Remove & Replace Entire Ramp.**
