## Access Compliance Report Public Rights-of-Way (Curb Ramps)

Intersection ID: 12348 Main Street: SOMERDALE\_LN Cross Street: WINEDALE\_LN Location: NW

ADA ID: E0C86EA0B42E Ramp Type: Perp Initial Pass/Fail: Fail Overall Compliance: No Severity Score: 26.25

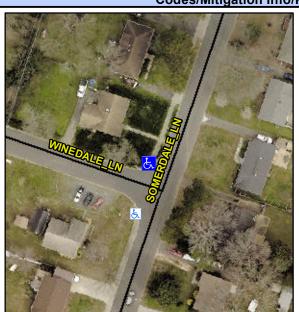
R304.2.2, R304.5.3

Field Measurements/Component Compliance					
Compliance Description		Data	Comp	liance Description	Data
N/A	Ramp Length (in)	58.0	No	Ramp Slope (%)	15.3
Yes	Ramp Width (in)	53.0	No	Ramp XSlope (%)	3.8
N/A	Flare Type LT	N/A	N/A	Flare Type RT	N/A
N/A	Flare Slope LT (%)	N/A	N/A	Flare Slope RT (%)	N/A
N/A	Flare Traversable LT?	N/A	N/A	Flare Traversable RT?	N/A
N/A	Landing Length (in)	N/A	N/A	DWS Provided?	N/A
N/A	Landing Width (in)	N/A	N/A	DWS Contrast?	N/A
N/A	Landing Slope (%)	N/A	N/A	DWS Length (in)	N/A
N/A	Landing X Slope (%)	N/A	N/A	DWS Full Width?	N/A
N/A	Landing Curb? (Y/N)	N/A	N/A	DWS Offset (in)	N/A
N/A	Shared Landing?	N/A			
N/A	Gutter Ponding?	N/A	N/A	Gutter Slope (%)	N/A
N/A	Gutter Lip Ht (in)	N/A	N/A	Gutter X Slope (%)	N/A
N/A	Painted X Walk1?	No	N/A	Painted X Walk2?	N/A
	X Walk 1 Direction	To SW		X Walk 2 Direction	N/A
N/A	X Walk 1 Width (in)	N/A	N/A	X Walk 2 Width (in)	N/A
	X Walk 1 Slope (%)	3.1		X Walk 2 Slope (%)	N/A

X Walk 1 X Slope (%)	7.1		X Walk 2 X Slope (%)	N/A
N/A	Ramp inside XWalk1?	N/A	N/A	Ramp inside XWalk2?	N/A
	Road Slope (%)	N/A	N/A	Clear Space?	N/A
	Road X Slope (%)	N/A	N/A	Clear Space to XWalk (in)	N/A
N/A	Any Obstructions?	N/A	N/A	Storm Grate/Utility Hazard?	N/A
	Obstruction Type			Storm Grate/Utility Type	
		N/A			N/A

Remove & Replace Entire Ramp.
