# Access Compliance Report

### (Curb Ramps)

Intersection ID: 4014	Main Street: DAVIS_LAKE_PY	Cross Street: DOWNING_CREEK_DR	Location: W
ADA ID: E0C9889DAB74	Ramp Type: BlendTrans1	Initial Pass/Fail: Fail	Overall Compliance: No
		Severity Score: 60

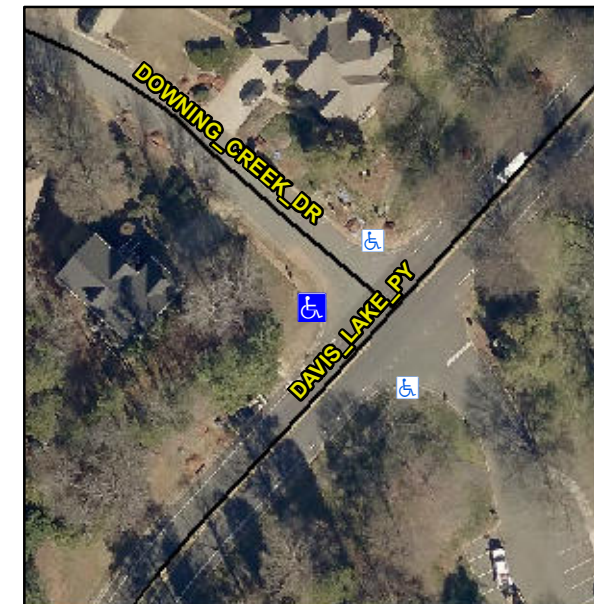
**Not Found, R304.5.1, R304.5.3**

Compliance	Description	Data	Compliance	Description	Data
N/A	Ramp Length (in)	50.0	Yes	BlendTrans Slope (%)	2.7
No	Ramp Width (in)	31.5	No	BlendTrans XSlope (%)	14.2
N/A	Flare Type LT	N/A	N/A	Flare Type RT	N/A
N/A	Flare Slope LT (%)	N/A	N/A	Flare Slope RT (%)	N/A
N/A	Flare Traversable LT?	N/A	N/A	Flare Traversable RT?	N/A
N/A	Landing Length (in)	N/A	N/A	DWS Provided?	N/A
N/A	Landing Width (in)	N/A	N/A	DWS Contrast?	N/A
N/A	Landing Slope (%)	N/A	N/A	DWS Length (in)	N/A
N/A	Landing X Slope (%)	N/A	N/A	DWS Full Width?	N/A
N/A	Landing Curb? (Y/N)	N/A	N/A	DWS Offset (in)	N/A
N/A	Shared Landing?	N/A			
N/A	Gutter Ponding?	N/A	N/A	Gutter Slope (%)	N/A
N/A	Gutter Lip Ht (in)	1.0	N/A	Gutter X Slope (%)	N/A
N/A	Painted X Walk1?	No	N/A	Painted X Walk2?	No
	X Walk 1 Direction	To SE		X Walk 2 Direction	To NE
	X Walk 1 Width (in)	N/A		X Walk 2 Width (in)	N/A
	X Walk 1 Slope (%)	5.0		X Walk 2 Slope (%)	4.7
	X Walk 1 X Slope (%)	8.6		X Walk 2 X Slope (%)	5.6

N/A	Ramp inside XWalk1?	N/A	N/A	Ramp inside XWalk2?	N/A
	Road Slope (%)	9.4		Clear Space?	N/A
	Road X Slope (%)	1.7	N/A	Clear Space to XWalk (in)	N/A
N/A	Any Obstructions?	N/A	N/A	Storm Grate/Utility Hazard?	N/A
	Obstruction Type			Storm Grate/Utility Type	
		N/A			N/A
			Yes	Surface Condition? (G/P)	Good
			No	Curb Slope (%)	6.5

**Remove & Replace Curb Ramp With Two New Directional Ramps or Equivalent.**
