Access Compliance Report

Public Rights-of-Way

(Curb Ramps)

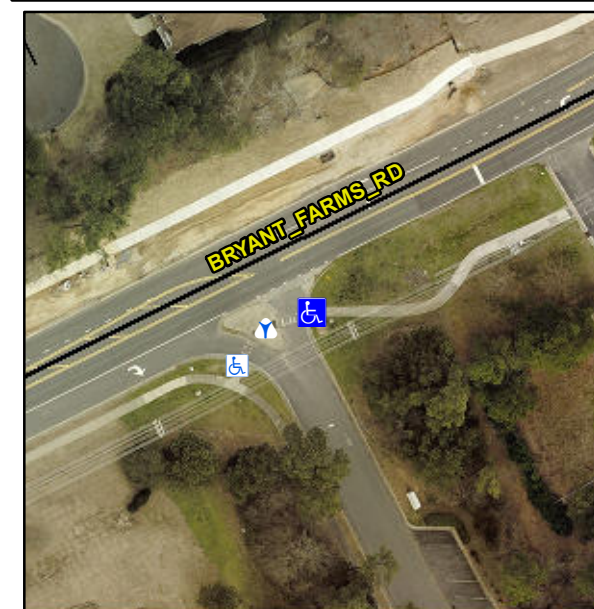
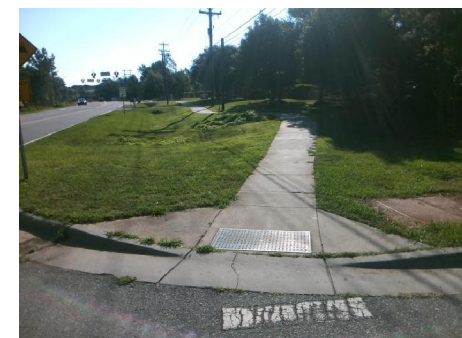
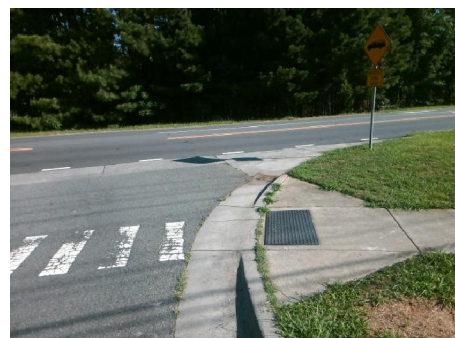
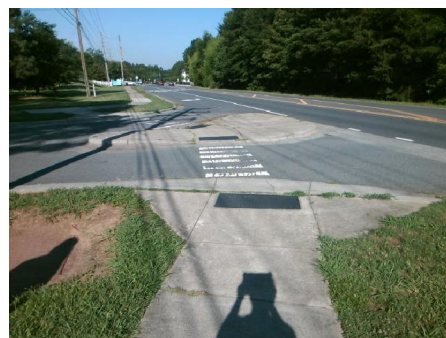
Intersection ID: 10022037	Main Street: BRYANT_FARMS_RD	Cross Street: N/A	Location: SE
ADA ID: E0CA353F8DCE	Ramp Type: BlendTrans1	Initial Pass/Fail: Pass	Overall Compliance: No
Severity Score: 0			
Codes/Mitigation Info/Possible Solution		Field Measurements/Component Compliance

Not Found, R304.2.1, R305.2, R302.7

Compliance	Description	Data	Compliance	Description	Data
N/A	Ramp Length (in)	71.0	Yes	BlendTrans Slope (%)	1.0
Yes	Ramp Width (in)	59.0	Yes	BlendTrans XSlope (%)	1.8
N/A	Flare Type LT	Sloped	N/A	Flare Type RT	Sloped
N/A	Flare Slope LT (%)	4.5	N/A	Flare Slope RT (%)	3.6
N/A	Flare Traversable LT?	No	N/A	Flare Traversable RT?	No
No	Landing Length (in)	37.0	Yes	DWS Provided?	Yes
Yes	Landing Width (in)	59.0	Yes	DWS Contrast?	Yes
Yes	Landing Slope (%)	0.1	Yes	DWS Length (in)	25.5
Yes	Landing X Slope (%)	0.7	Yes	DWS Full Width?	Yes
N/A	Landing Curb? (Y/N)	No	No	DWS Offset (in)	4.0
N/A	Shared Landing?	No			
No	Gutter Ponding?	Yes	Yes	Gutter Slope (%)	2.6
Yes	Gutter Lip Ht (in)	0.0	Yes	Gutter X Slope (%)	1.0
N/A	Painted X Walk1?	Yes	N/A	Painted X Walk2?	N/A
	X Walk 1 Direction	To W		X Walk 2 Direction	N/A
	X Walk 1 Width (in)	48.0		X Walk 2 Width (in)	N/A
	X Walk 1 Slope (%)	1.0		X Walk 2 Slope (%)	N/A
	X Walk 1 X Slope (%)	0.0		X Walk 2 X Slope (%)	N/A

Yes	Ramp inside XWalk1?	Yes	N/A	Ramp inside XWalk2?	N/A
	Road Slope (%)	0.0		Clear Space?	Yes
	Road X Slope (%)	1.0	N/A	Clear Space to XWalk (in)	N/A
Yes	Any Obstructions?	No	Yes	Storm Grate/Utility Hazard?	No
	Obstruction Type			Storm Grate/Utility Type	
		N/A			N/A
			Yes	Surface Condition? (G/P)	Good
			No	Curb Slope (%)	7.2

Remove & Replace Curb Ramp With Two New Directional Ramps or Equivalent.
