Access Compliance Report

Public Rights-of-Way

(Curb Ramps)

Intersection ID: 21723	Main Street: BALLENCOURT_LN	Cross Street: COLONY_RD	Location:	N
ADA ID: E0CC0B0C226A	Ramp Type: BlendTrans2	Initial Pass/Fail: Fail	Overall Compliance: No	Severity Score: 47.5

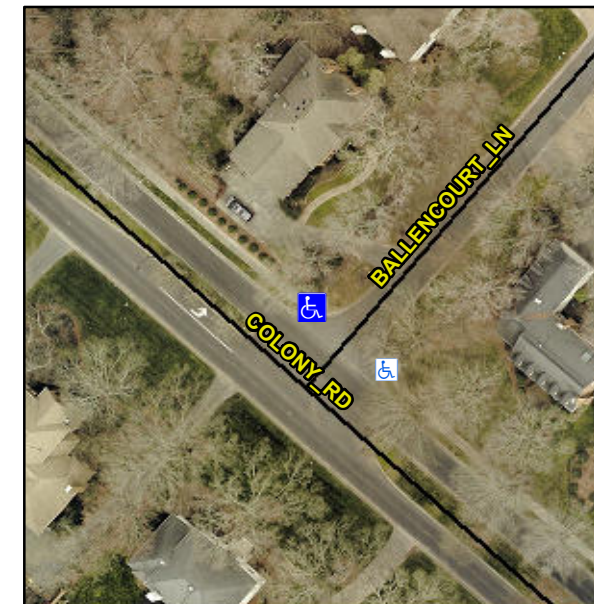
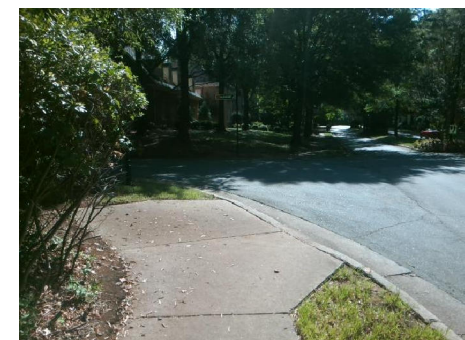
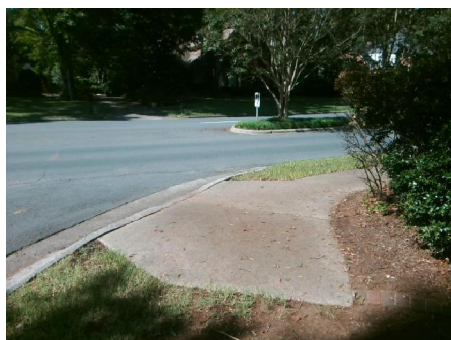
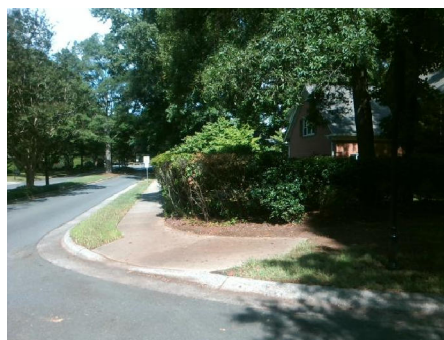
Not Found, R304.5.1, R304.5.3

Compliance	Description	Data	Compliance	Description	Data
N/A	Ramp Length (in)	96.0	Yes	BlendTrans Slope (%)	4.7
No	Ramp Width (in)	30.0	No	BlendTrans XSlope (%)	5.2
N/A	Flare Type LT	N/A	N/A	Flare Type RT	N/A
N/A	Flare Slope LT (%)	N/A	N/A	Flare Slope RT (%)	N/A
N/A	Flare Traversable LT?	N/A	N/A	Flare Traversable RT?	N/A
N/A	Landing Length (in)	N/A	N/A	DWS Provided?	N/A
N/A	Landing Width (in)	N/A	N/A	DWS Contrast?	N/A
N/A	Landing Slope (%)	N/A	N/A	DWS Length (in)	N/A
N/A	Landing X Slope (%)	N/A	N/A	DWS Full Width?	N/A
N/A	Landing Curb? (Y/N)	N/A	N/A	DWS Offset (in)	N/A
N/A	Shared Landing?	N/A			
N/A	Gutter Ponding?	N/A	N/A	Gutter Slope (%)	N/A
N/A	Gutter Lip Ht (in)	N/A	N/A	Gutter X Slope (%)	N/A
N/A	Painted X Walk1?	No	N/A	Painted X Walk2?	No
	X Walk 1 Direction	To SW		X Walk 2 Direction	To SE
	X Walk 1 Width (in)	N/A		X Walk 2 Width (in)	N/A
	X Walk 1 Slope (%)	5.4		X Walk 2 Slope (%)	3.1
	X Walk 1 X Slope (%)	4.2		X Walk 2 X Slope (%)	3.3

N/A	Ramp inside XWalk1?	N/A	N/A	Ramp inside XWalk2?	N/A
	Road Slope (%)	7.6		Clear Space?	N/A
	Road X Slope (%)	1.9	N/A	Clear Space to XWalk (in)	N/A
N/A	Any Obstructions?	N/A	N/A	Storm Grate/Utility Hazard?	N/A
	Obstruction Type			Storm Grate/Utility Type	
		N/A			N/A
			Yes	Surface Condition? (G/P)	Good
			No	Curb Slope (%)	10.8

Remove & Replace Curb Ramp With Two New Directional Ramps or Equivalent.
