Access Compliance Report

Public Rights-of-Way

(Curb Ramps)

Intersection ID: 50747	Main Street: MONTELENA_DR	Cross Street: ARTESA_CT	Location: W
ADA ID: E0CD6E6EDC13	Ramp Type: PerpDiag	Initial Pass/Fail: Fail	Overall Compliance: No
		Severity Score: 10

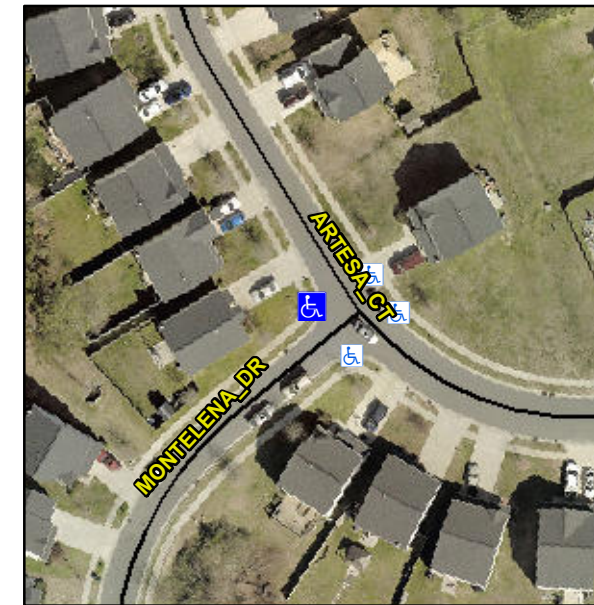
Not Found, R304.5.1, R304.5.3

Compliance	Description	Data	Compliance	Description	Data
N/A	Ramp Length (in)	48.5	Yes	Ramp Slope (%)	8.0
No	Ramp Width (in)	47.0	No	Ramp XSlope (%)	4.5
N/A	Flare Type LT	N/A	N/A	Flare Type RT	N/A
N/A	Flare Slope LT (%)	N/A	N/A	Flare Slope RT (%)	N/A
N/A	Flare Traversable LT?	N/A	N/A	Flare Traversable RT?	N/A
N/A	Landing Length (in)	N/A	N/A	DWS Provided?	N/A
N/A	Landing Width (in)	N/A	N/A	DWS Contrast?	N/A
N/A	Landing Slope (%)	N/A	N/A	DWS Length (in)	N/A
N/A	Landing X Slope (%)	N/A	N/A	DWS Full Width?	N/A
N/A	Landing Curb? (Y/N)	N/A	N/A	DWS Offset (in)	N/A
N/A	Shared Landing?	N/A			
N/A	Gutter Ponding?	N/A	N/A	Gutter Slope (%)	N/A
N/A	Gutter Lip Ht (in)	N/A	N/A	Gutter X Slope (%)	N/A
N/A	Painted X Walk1?	No	N/A	Painted X Walk2?	No
	X Walk 1 Direction	To SE		X Walk 2 Direction	To NE
N/A	X Walk 1 Width (in)	N/A	N/A	X Walk 2 Width (in)	N/A
	X Walk 1 Slope (%)	2.8		X Walk 2 Slope (%)	5.9
	X Walk 1 X Slope (%)	1.4		X Walk 2 X Slope (%)	2.1

Remove & Replace Curb Ramp With Two New Directional Ramps or Equivalent.
