Access Compliance Report

Public Rights-of-Way

(Curb Ramps)

Intersection ID: 10036931	Main Street: S_SHARON_AMITY_RD	Cross Street: N/A	Location: NE
ADA ID: E0D5543C426A	Ramp Type: ParaDiag	Initial Pass/Fail: Fail	Overall Compliance: No
Codes/Mitigation Info/Possible Solution		Field Measurements/Component Compliance	
Severity Score: 13.75

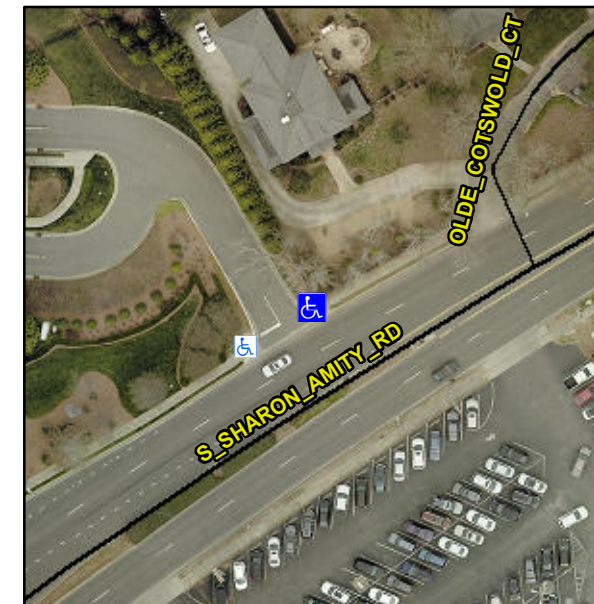
RT RP < 5%

Compliance	Description	Data	Compliance	Description	Data
N/A	Ramp Length LT (in)	52.0	N/A	Ramp Length RT (in)	50.0
Yes	Ramp Width LT (in)	63.0	Yes	Ramp Width RT (in)	64.0
No	Ramp Slope LT (%)	8.4	Yes	Ramp Slope RT (%)	1.0
Yes	Ramp XSlope LT (%)	1.5	No	Ramp XSlope RT (%)	2.4
N/A	Landing Length (in)	N/A	N/A	DWS Provided?	N/A
N/A	Landing Width (in)	N/A	N/A	DWS Contrast?	N/A
N/A	Landing Slope (%)	N/A	N/A	DWS Length (in)	N/A
N/A	Landing X Slope (%)	N/A	N/A	DWS Full Width?	N/A
N/A	Landing Curb? (Y/N)	N/A	N/A	DWS Offset (in)	N/A
N/A	Shared Landing?	N/A			
N/A	Gutter Ponding?	N/A	N/A	Gutter Slope (%)	N/A
N/A	Gutter Lip Ht (in)	N/A	N/A	Gutter X Slope (%)	N/A
N/A	Painted X Walk1?	No	N/A	Painted X Walk2?	No
	X Walk 1 Direction	To SW		X Walk 2 Direction	To SE
N/A	X Walk 1 Width (in)	N/A	N/A	X Walk 2 Width (in)	N/A
	X Walk 1 Slope (%)	2.8		X Walk 2 Slope (%)	4.1
	X Walk 1 X Slope (%)	5.5		X Walk 2 X Slope (%)	2.3
N/A	Ramp inside XWalk1?	N/A	N/A	Ramp inside XWalk2?	N/A

Road Slope (%)	3.2	N/A	Clear Space?	N/A
	Road X Slope (%)	3.1	N/A	Clear Space to XWalk (in)	N/A
N/A	Any Obstructions?	N/A	N/A	Storm Grate/Utility Hazard?	N/A
	Obstruction Type			Storm Grate/Utility Type	
		N/A			N/A
			Yes	Surface Condition? (G/P)	Good
			N/A	Curb Slope (%)	6.3

Possible Solutions:

Remove & Replace Curb Ramp With Two New Directional Ramps or Equivalent.

R304.3.2, R304.5.3
