Access Compliance Report

Public Rights-of-Way

(Curb Ramps)

Intersection ID: 24214	Main Street: HENSEY'S_WY	Cross Street: BEVERLY_CREST_BV	Location: SE
ADA ID: E0DA4760C084	Ramp Type: Perp	Initial Pass/Fail: Fail	Overall Compliance: No
Severity Score: 37.5			
Codes/Mitigation Info/Possible Solution		Field Measurements/Component Compliance

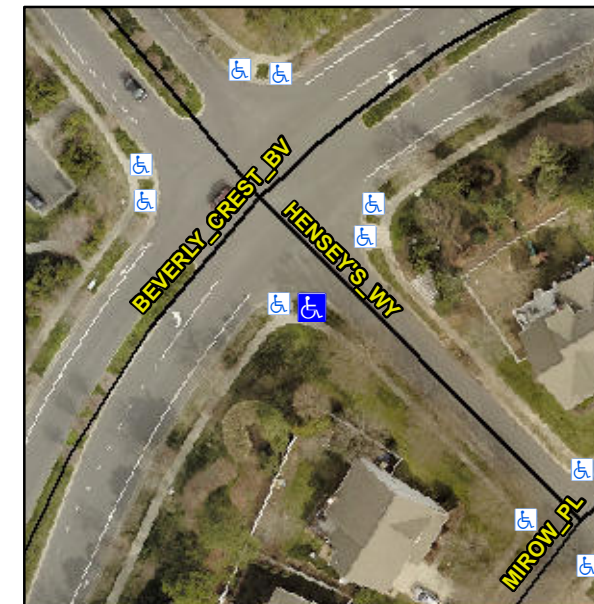
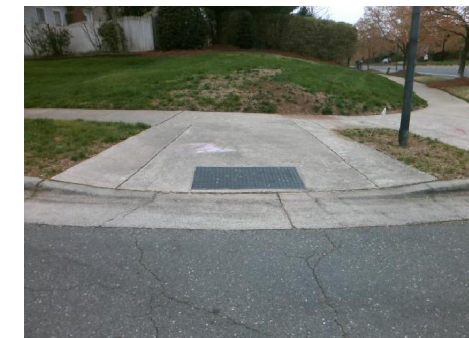
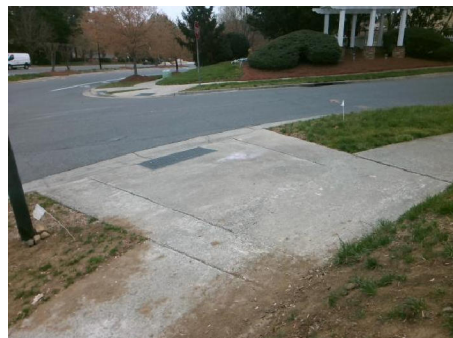
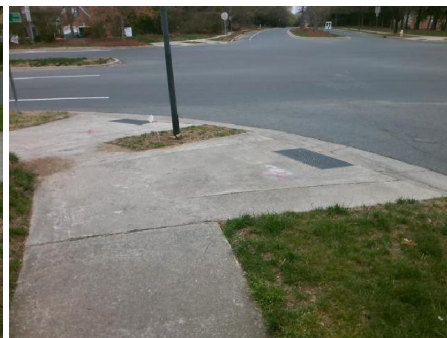
Not Found, R304.2.2, R304.5.3

Compliance	Description	Data	Compliance	Description	Data
N/A	Ramp Length (in)	99.0	No	Ramp Slope (%)	11.1
Yes	Ramp Width (in)	77.0	No	Ramp XSlope (%)	7.2
N/A	Flare Type LT	N/A	N/A	Flare Type RT	N/A
N/A	Flare Slope LT (%)	N/A	N/A	Flare Slope RT (%)	N/A
N/A	Flare Traversable LT?	N/A	N/A	Flare Traversable RT?	N/A
N/A	Landing Length (in)	N/A	N/A	DWS Provided?	N/A
N/A	Landing Width (in)	N/A	N/A	DWS Contrast?	N/A
N/A	Landing Slope (%)	N/A	N/A	DWS Length (in)	N/A
N/A	Landing X Slope (%)	N/A	N/A	DWS Full Width?	N/A
N/A	Landing Curb? (Y/N)	N/A	N/A	DWS Offset (in)	N/A
N/A	Shared Landing?	N/A			
N/A	Gutter Ponding?	N/A	N/A	Gutter Slope (%)	N/A
N/A	Gutter Lip Ht (in)	N/A	N/A	Gutter X Slope (%)	N/A
N/A	Painted X Walk1?	No	N/A	Painted X Walk2?	N/A
	X Walk 1 Direction	To NE		X Walk 2 Direction	N/A
N/A	X Walk 1 Width (in)	N/A	N/A	X Walk 2 Width (in)	N/A
	X Walk 1 Slope (%)	3.1		X Walk 2 Slope (%)	N/A
	X Walk 1 X Slope (%)	8.8		X Walk 2 X Slope (%)	N/A

N/A	Ramp inside XWalk1?	N/A	N/A	Ramp inside XWalk2?	N/A
	Road Slope (%)	N/A	N/A	Clear Space?	N/A
	Road X Slope (%)	N/A	N/A	Clear Space to XWalk (in)	N/A
N/A	Any Obstructions?	N/A	N/A	Storm Grate/Utility Hazard?	N/A
	Obstruction Type			Storm Grate/Utility Type	
		N/A			N/A
			Yes	Surface Condition? (G/P)	Good

Possible Solutions:

Remove & Replace Entire Ramp.
