# Access Compliance Report

## Public Rights-of-Way

| Intersection ID: 4457 | Main Street: OLD_STATESVILLE_RD | Cross Street: LABORDE_AV | Location: SW |
| ADA ID: E0EF721393AF | Ramp Type: Perp | Initial Pass/Fail: Fail | Overall Compliance: No |

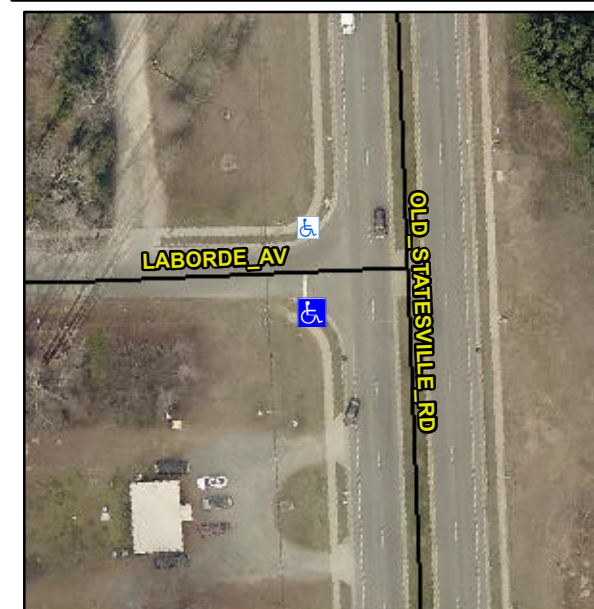
| Severity Score: 21.25 | | | |

**Not Found, R304.5.1, R304.2.2**

| Compliance | Description | Data | Compliance | Description | Data |
|---|---|---|---|---|---|
| N/A | Ramp Length (in) | 59.0 | No | Ramp Slope (%) | 9.2 |
| No | Ramp Width (in) | 42.0 | Yes | Ramp XSlope (%) | 1.1 |

**Remove & Replace Entire Ramp.**

Total Cost: \$ 1850.00
