# Access Compliance Report

## Public Rights-of-Way

### (Curb Ramps)

| Intersection ID: 14442 | Main Street: N_SHARON_AMITY_RD | Cross Street: CENTRAL_AV | Location: N |

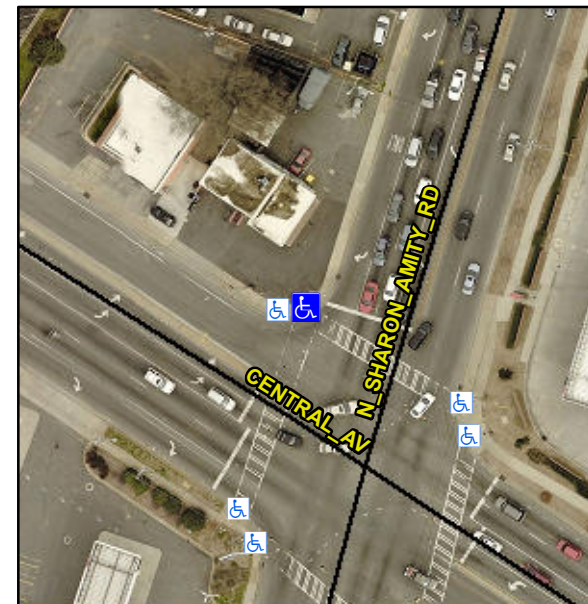
**R304.5.3, R304.2.1, R304.2.2-Perp,  
R304.3.2-Para**

| Compliance | Description | Data | Compliance | Description | Data |
|---|---|---|---|---|---|
| No | Ramp XSlope LT (%) | 2.3 | No | Ramp XSlope RT (%) | 3.3 |
| No | Landing Width (in) | 39.0 | Yes | DWS Contrast? | Yes |
| No | Landing Slope (%) | 3.3 | Yes | DWS Length (in) | 25.5 |
| No | Landing X Slope (%) | 2.6 | Yes | DWS Full Width? | Yes |

**Remove & Replace Entire Ramp.**
