Access Compliance Report

Public Rights-of-Way

(Curb Ramps)

Intersection ID: 10038888	Main Street: STINSON_CT	Cross Street: N/A	Location: E
ADA ID: E0F415DA28C5	Ramp Type: Perp	Initial Pass/Fail: Fail	Overall Compliance: No
Severity Score: 10			
Codes/Mitigation Info/Possible Solution		Field Measurements/Component Compliance

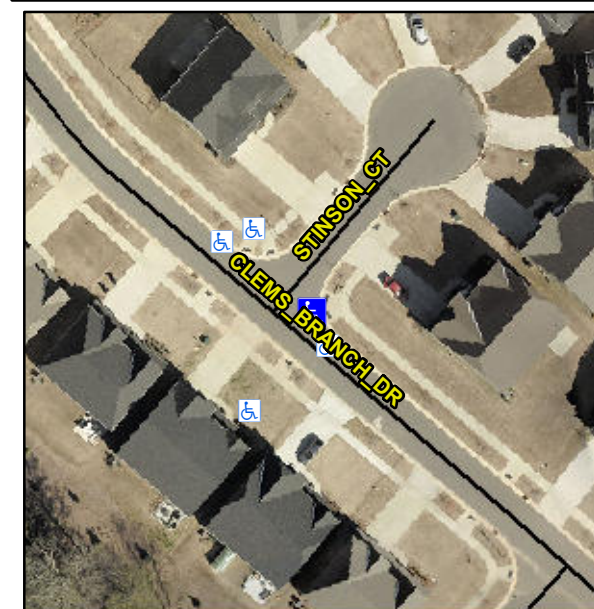
Not Found, R304.5.1, R304.5.3

Compliance	Description	Data	Compliance	Description	Data
N/A	Ramp Length (in)	96.0	Yes	Ramp Slope (%)	5.3
No	Ramp Width (in)	46.0	No	Ramp XSlope (%)	2.4
N/A	Flare Type LT	N/A	N/A	Flare Type RT	N/A
N/A	Flare Slope LT (%)	N/A	N/A	Flare Slope RT (%)	N/A
N/A	Flare Traversable LT?	N/A	N/A	Flare Traversable RT?	N/A
N/A	Landing Length (in)	N/A	N/A	DWS Provided?	N/A
N/A	Landing Width (in)	N/A	N/A	DWS Contrast?	N/A
N/A	Landing Slope (%)	N/A	N/A	DWS Length (in)	N/A
N/A	Landing X Slope (%)	N/A	N/A	DWS Full Width?	N/A
N/A	Landing Curb? (Y/N)	N/A	N/A	DWS Offset (in)	N/A
N/A	Shared Landing?	N/A			
N/A	Gutter Ponding?	N/A	N/A	Gutter Slope (%)	N/A
N/A	Gutter Lip Ht (in)	N/A	N/A	Gutter X Slope (%)	N/A
N/A	Painted X Walk1?	No	N/A	Painted X Walk2?	N/A
	X Walk 1 Direction	To NW		X Walk 2 Direction	N/A
N/A	X Walk 1 Width (in)	N/A	N/A	X Walk 2 Width (in)	N/A
	X Walk 1 Slope (%)	5.8		X Walk 2 Slope (%)	N/A
	X Walk 1 X Slope (%)	0.0		X Walk 2 X Slope (%)	N/A

N/A	Ramp inside XWalk1?	N/A	N/A	Ramp inside XWalk2?	N/A
	Road Slope (%)	N/A	N/A	Clear Space?	N/A
	Road X Slope (%)	N/A	N/A	Clear Space to XWalk (in)	N/A
N/A	Any Obstructions?	N/A	N/A	Storm Grate/Utility Hazard?	N/A
	Obstruction Type			Storm Grate/Utility Type	
		N/A			N/A
			Yes	Surface Condition? (G/P)	Good

Possible Solutions:

Remove & Replace Entire Ramp.
