Access Compliance Report

Public Rights-of-Way

(Curb Ramps)

Intersection ID: 49124	Main Street: CLARKE_CREEK_PY	Cross Street: LEGOLAS_LN	Location: SE
ADA ID: E0F463978B12	Ramp Type: PerpDiag	Initial Pass/Fail: Fail	Overall Compliance: No
Severity Score: 8.75			
Codes/Mitigation Info/Possible Solution		Field Measurements/Component Compliance

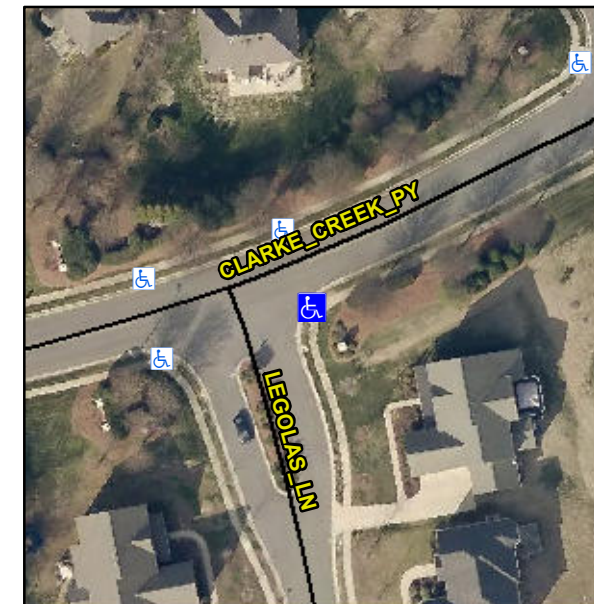
Compliance	Description	Data	Compliance	Description	Data
N/A	Ramp Length (in)	48.0	Yes	Ramp Slope (%)	5.4
No	Ramp Width (in)	46.0	Yes	Ramp XSlope (%)	1.2
N/A	Flare Type LT	N/A	N/A	Flare Type RT	N/A
N/A	Flare Slope LT (%)	N/A	N/A	Flare Slope RT (%)	N/A
N/A	Flare Traversable LT?	N/A	N/A	Flare Traversable RT?	N/A
N/A	Landing Length (in)	N/A	N/A	DWS Provided?	N/A
N/A	Landing Width (in)	N/A	N/A	DWS Contrast?	N/A
N/A	Landing Slope (%)	N/A	N/A	DWS Length (in)	N/A
N/A	Landing X Slope (%)	N/A	N/A	DWS Full Width?	N/A
N/A	Landing Curb? (Y/N)	N/A	N/A	DWS Offset (in)	N/A
N/A	Shared Landing?	N/A			
N/A	Gutter Ponding?	N/A	N/A	Gutter Slope (%)	N/A
N/A	Gutter Lip Ht (in)	N/A	N/A	Gutter X Slope (%)	N/A
N/A	Painted X Walk1?	No	N/A	Painted X Walk2?	No
	X Walk 1 Direction	To N		X Walk 2 Direction	To W
N/A	X Walk 1 Width (in)	N/A	N/A	X Walk 2 Width (in)	N/A
	X Walk 1 Slope (%)	3.0		X Walk 2 Slope (%)	2.0
	X Walk 1 X Slope (%)	2.6		X Walk 2 X Slope (%)	2.6

N/A	Ramp inside XWalk1?	N/A	N/A	Ramp inside XWalk2?	N/A
	Road Slope (%)	0.2	N/A	Clear Space?	N/A
	Road X Slope (%)	3.3	N/A	Clear Space to XWalk (in)	N/A
N/A	Any Obstructions?	N/A	N/A	Storm Grate/Utility Hazard?	N/A
	Obstruction Type			Storm Grate/Utility Type	
		N/A			N/A
		Yes		Surface Condition? (G/P)	Good

Remove & Replace Curb Ramp With Two New Directional Ramps or Equivalent.

R304.5.1
