Access Compliance Report

Public Rights-of-Way

(Curb Ramps)

| Intersection ID: 21478 | Main Street: KILCULLEN_DR | Cross Street: N/A | Location: NE |

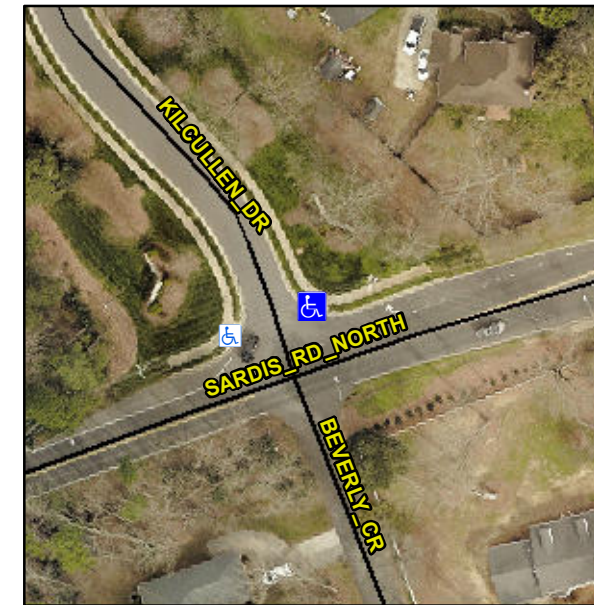
| ADA ID: E0F62FCF7E35 | Ramp Type: PerpDiag | Initial Pass/Fail: Fail | Overall Compliance: No |
| | | Severity Score: 12.5 | |

Not Found, R304.5.3

| Compliance | Description | Data | Compliance | Description | Data |
|---|---|---|---|---|---|
| Yes | Ramp Width (in) | 48.0 | No | Ramp XSlope (%) | 5.5 |

Remove & Replace Curb Ramp With Two New Directional Ramps or Equivalent.
