Access Compliance Report

Public Rights-of-Way

(Curb Ramps)

Intersection ID: 3233	Main Street: HERITAGE_HILLS_LN	Cross Street: PROSPERITY_CHURCH_RD	Location: SW
ADA ID: E0FA3EB4D63C	Ramp Type: Perp	Initial Pass/Fail: Fail	Overall Compliance: No
Severity Score: 22.5			
Codes/Mitigation Info/Possible Solution		Field Measurements/Component Compliance

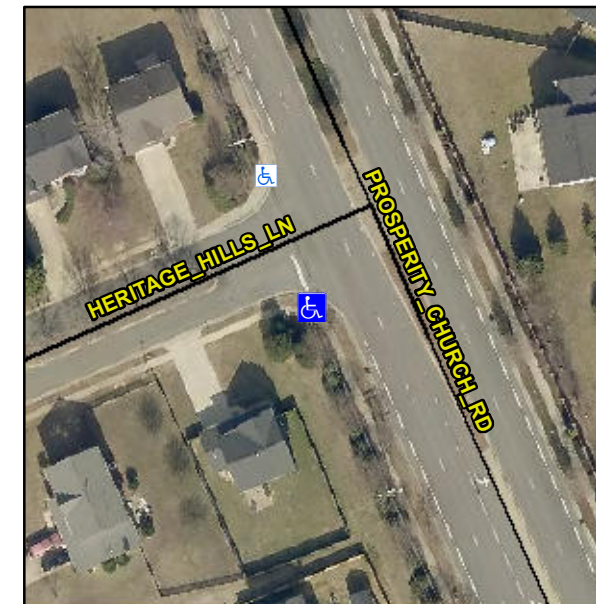
Not Found, R304.5.1, R304.2.2, R304.5.3

Compliance	Description	Data	Compliance	Description	Data
N/A	Ramp Length (in)	85.0	No	Ramp Slope (%)	8.4
No	Ramp Width (in)	36.0	No	Ramp XSlope (%)	3.9
N/A	Flare Type LT	N/A	N/A	Flare Type RT	N/A
N/A	Flare Slope LT (%)	N/A	N/A	Flare Slope RT (%)	N/A
N/A	Flare Traversable LT?	N/A	N/A	Flare Traversable RT?	N/A
N/A	Landing Length (in)	N/A	N/A	DWS Provided?	N/A
N/A	Landing Width (in)	N/A	N/A	DWS Contrast?	N/A
N/A	Landing Slope (%)	N/A	N/A	DWS Length (in)	N/A
N/A	Landing X Slope (%)	N/A	N/A	DWS Full Width?	N/A
N/A	Landing Curb? (Y/N)	N/A	N/A	DWS Offset (in)	N/A
N/A	Shared Landing?	N/A			
N/A	Gutter Ponding?	N/A	N/A	Gutter Slope (%)	N/A
N/A	Gutter Lip Ht (in)	N/A	N/A	Gutter X Slope (%)	N/A
N/A	Painted X Walk1?	No	N/A	Painted X Walk2?	N/A
	X Walk 1 Direction	To N		X Walk 2 Direction	N/A
N/A	X Walk 1 Width (in)	N/A	N/A	X Walk 2 Width (in)	N/A
	X Walk 1 Slope (%)	1.9		X Walk 2 Slope (%)	N/A
	X Walk 1 X Slope (%)	6.7		X Walk 2 X Slope (%)	N/A

N/A	Ramp inside XWalk1?	N/A	N/A	Ramp inside XWalk2?	N/A
	Road Slope (%)	N/A	N/A	Clear Space?	N/A
	Road X Slope (%)	N/A	N/A	Clear Space to XWalk (in)	N/A
N/A	Any Obstructions?	N/A	N/A	Storm Grate/Utility Hazard?	N/A
	Obstruction Type			Storm Grate/Utility Type	
		N/A			N/A
			Yes	Surface Condition? (G/P)	Good

Possible Solutions:

Remove & Replace Entire Ramp.
